## **COMMITTEE OF THE WHOLE – JANUARY 12, 2010**

### **HERITAGE CLEARANCE APPLICATION, 12000 HIGHWAY 27 (HAMBLY HOUSE)**

The purpose of this report is to review the Heritage Clearance application for the demolition of the structure at 12000 Highway 27.

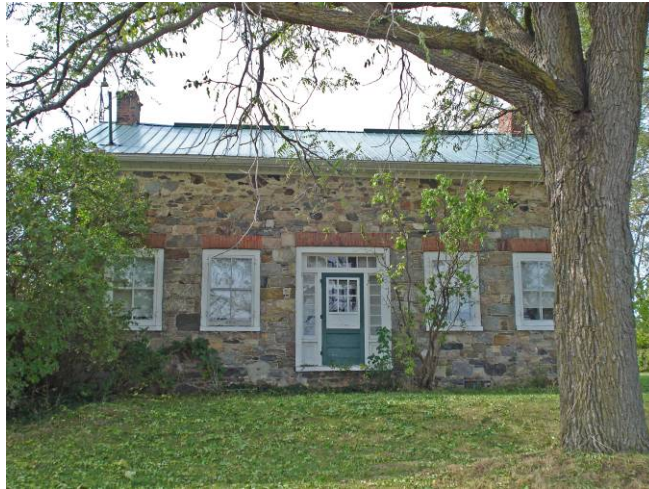
**Figure 2 Front Elevation of 12000 Highway 27**

- Many of the original diagnostic decorative features, such as the verandah, original roofing and cornice details have been removed.
- On the front elevation above the window trim is a horizontal line of wood blocks in the place of fieldstone. This indicates that there was probably a verandah along the front elevation at one point. It is also possible that the verandah and missing front step were never installed. Tax law of the time required that property taxes were only to be paid on finished homes, by leaving these elements incomplete the owner could avoid paying taxes on the structure.

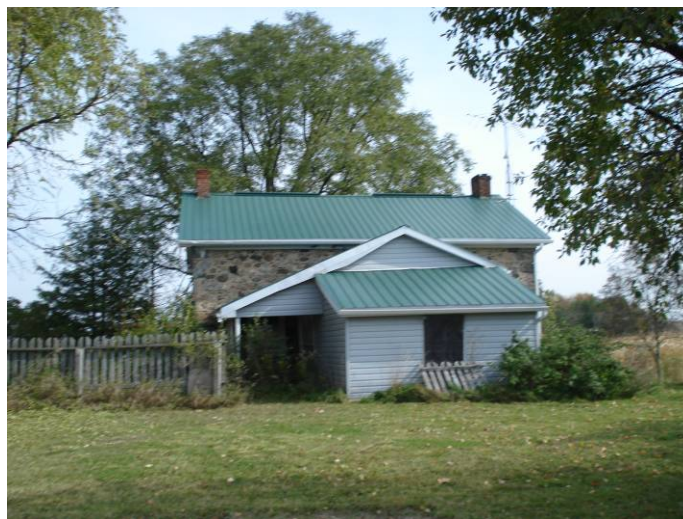
**Figure 3 Rear Elevation of 12000 Highway 27**

- The roof, soffits, eaves, eaves troughs and cornice have recently been removed or replaced, although they appear to be failing due to neglect.
- There are two winged additions on the rear elevation, a "summer kitchen" addition off of the main kitchen and a small storage space off of the summer kitchen addition. These are both clad in plastic siding, although they would have originally have been clad in wood siding.

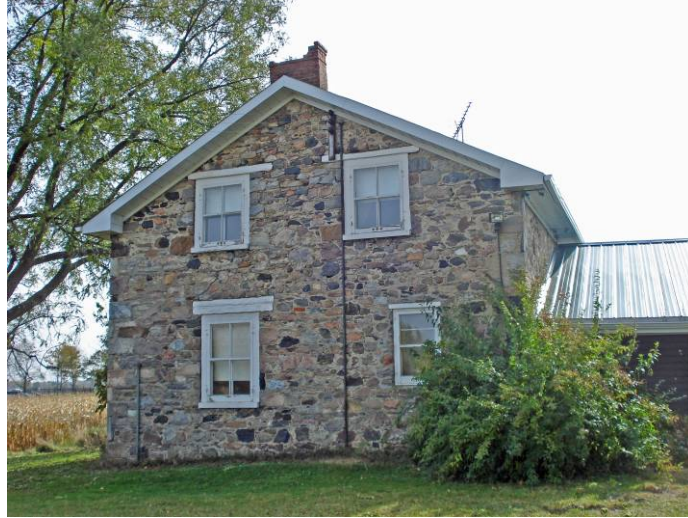
**Figure 4 Northern Side Elevation of 12000 Highway 27**

- The masonry is in poor condition in particular the at north elevation. The underlying secondary brick wall is exposed in several places, and is also deteriorating. Like the South elevation, the masonry is notably less coursed and regular and the windows are asymmetrical.

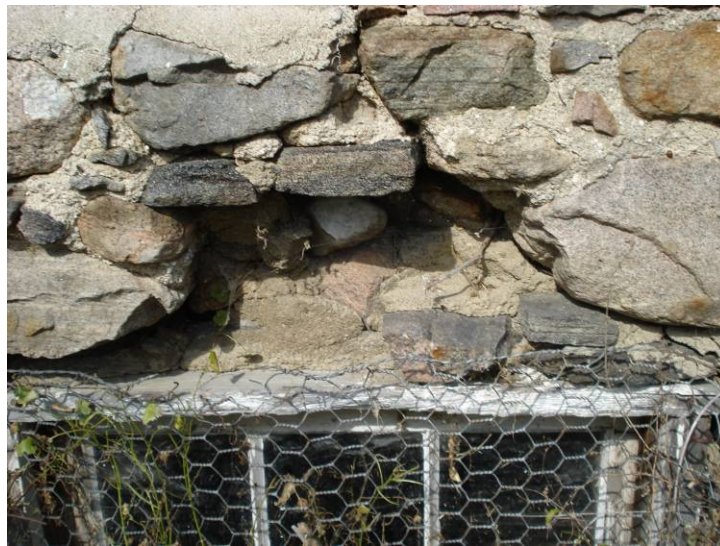
**Figure 6 Secondary Stone Masonry Wall Exposed on the Southern Side Elevation**

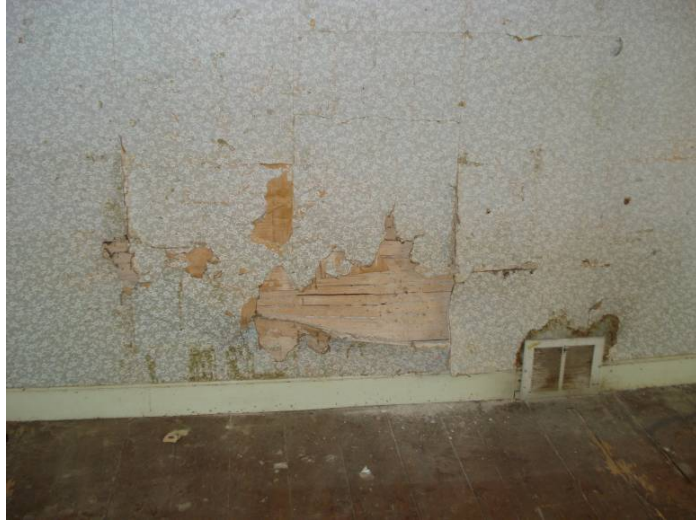
- Lathe and plaster walls intact in some places, but severely water damaged in others.
- Summer kitchen and main kitchen in very poor condition; both have been unsympathetically altered.

**Figure 7 Exposed Lathe and Plaster on First Floor, Severely Water Damaged**

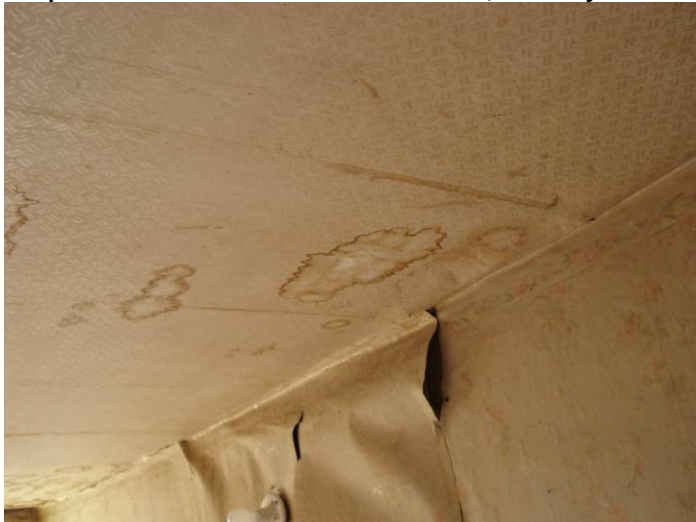
- Wide pine, possibly original, flooring in upper level is water damaged save for a few sections.
- Upper level walls and ceilings are severely water damaged.

- Although it was not possible to enter the attic area, it is evident there is persistent moisture penetration through the metal roof. Mould is present throughout the structure.

**Figure 8 Upper Floor Water Damage, Through Attic and Down Walls**

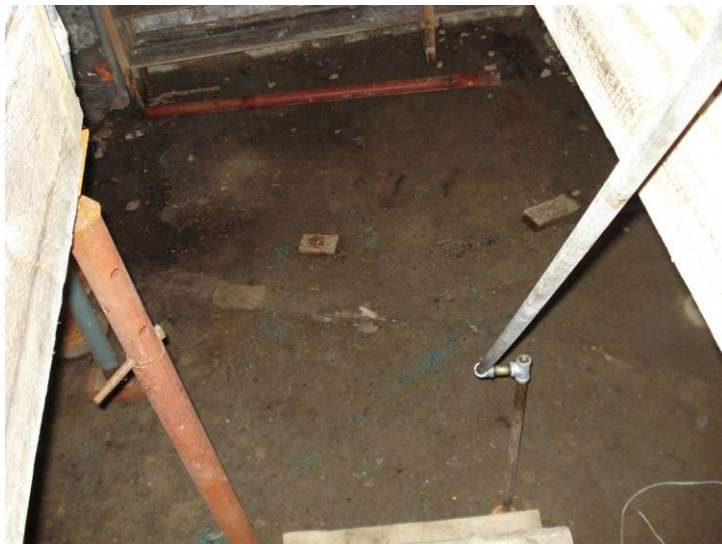
- The basement walls and concrete floor appeared very wet, but not flooded. A large crack throughout the poured cement could be seen from the top of the stairs.

- Newer metal support post installed in the basement where the wooden floor beams were sagging is evidence of some wood post and beam substructural instability.

**Figure 9 Large Crack in Basement Poured Concrete Floor, Recent Metal Support Post**

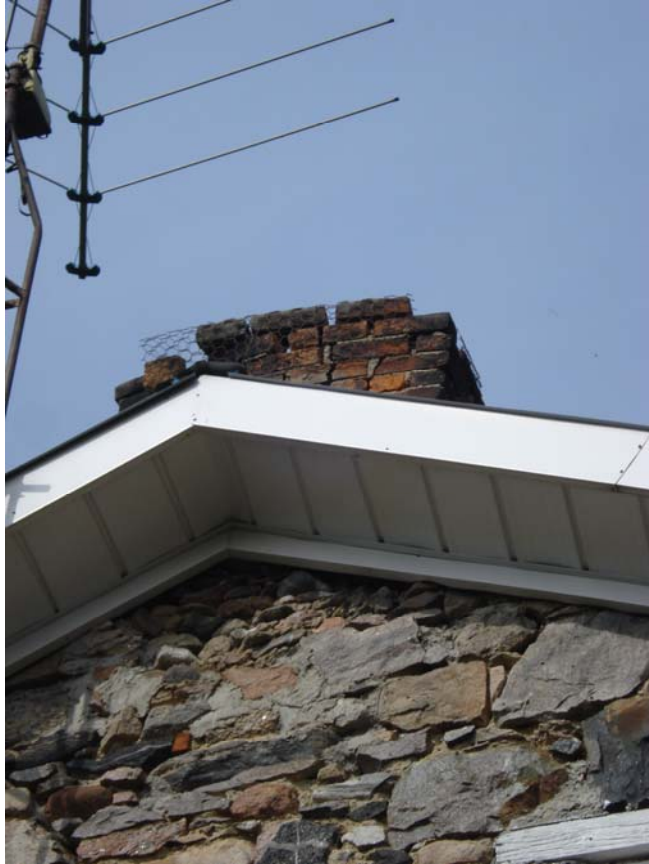
**Figure 10 Spalling chimney with little remaining mortar, held together with chicken wire.**

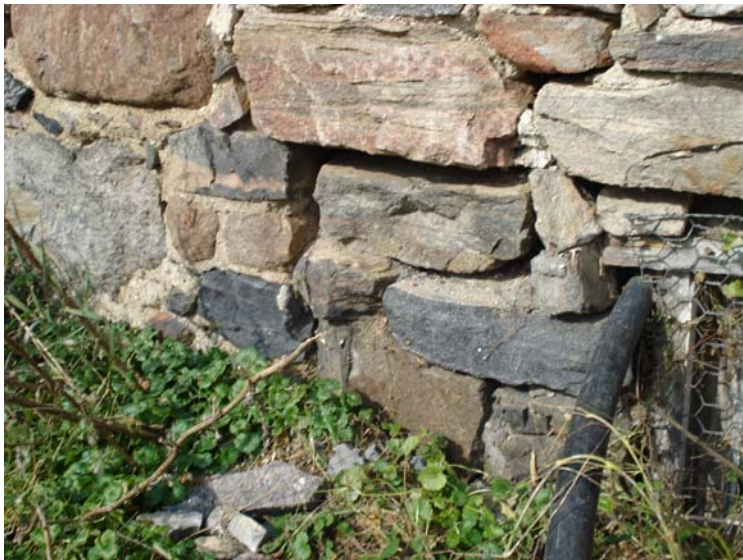
- The rubble stone foundation walls require extensive repair.

**Figure 11 Failing stone masonry foundation.**
