## **COMMITTEE OF THE WHOLE – NOVEMBER 21, 2005**

### **THE GRAHAM HOUSE, 9933 DUFFERIN STREET**

**HERITAGE BUILDING EVALUATION  
9933 DUFFERIN STREET, WILLIAM GRAHAM HOUSE**

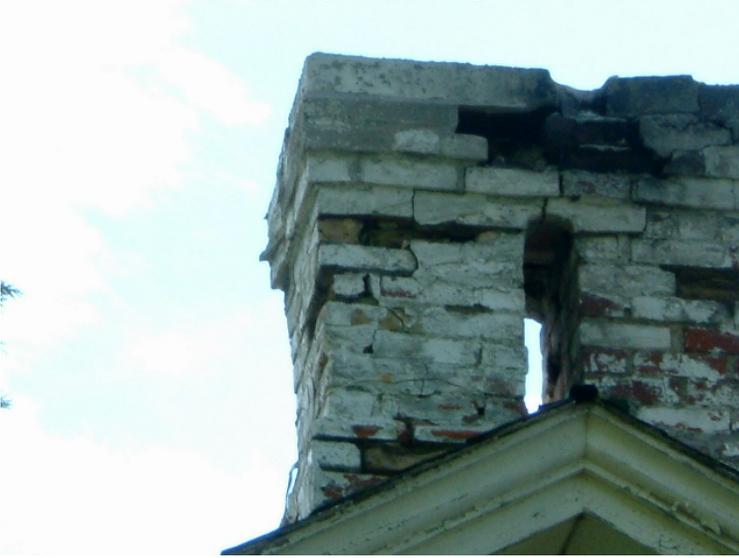
- Brick shows extensive spalling and mortar cracking on south west and east elevation. The entire brickwork of the house was painted and the paint is now peeling away from the brickwork (this has no structural ramifications, and is only a cosmetic detail).
- The two brick chimneys on the roof show severe spalling and is missing some supporting bricks.

Chimney (Brickwork spalling and missing bricks)

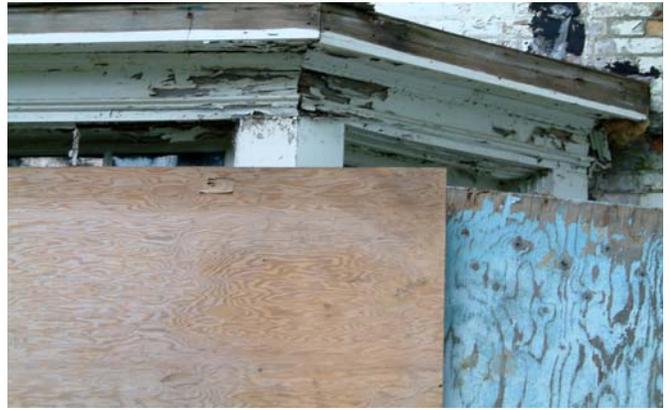
Wood deterioration by water/moisture at east elevation

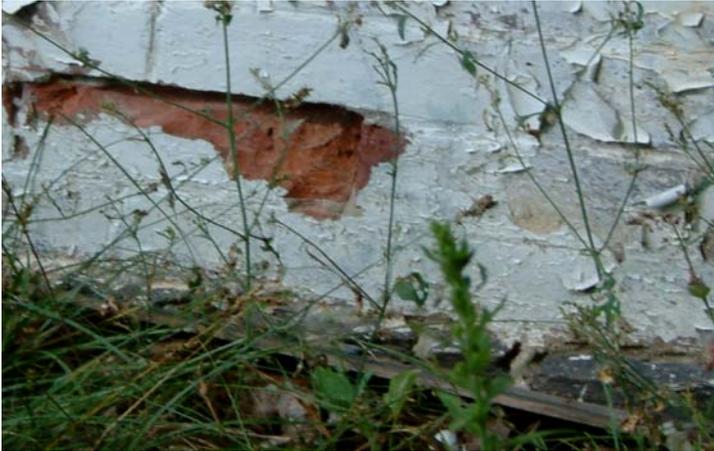
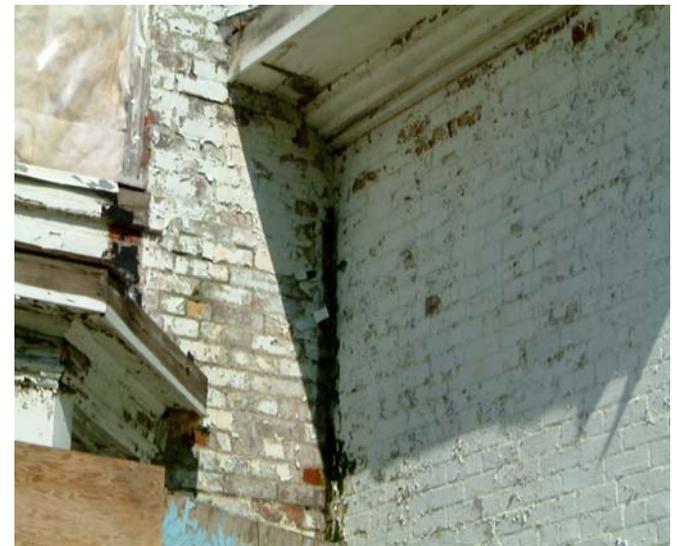
Brickwork Spalling at East Elevation

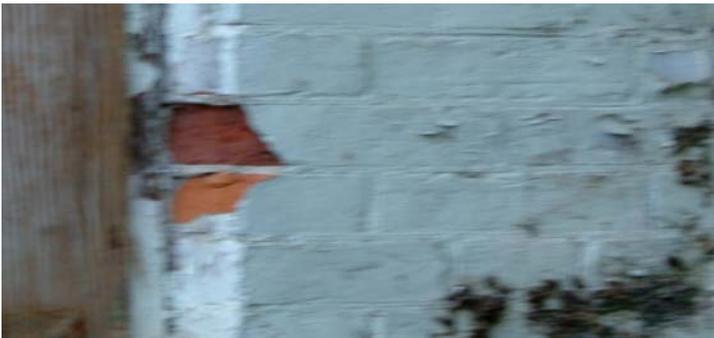
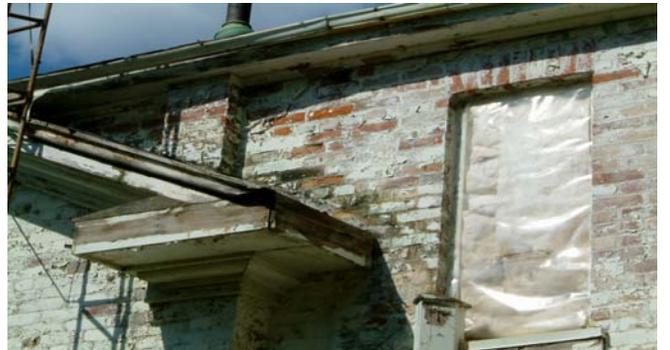
Wood deterioration by water/moisture at east elevation

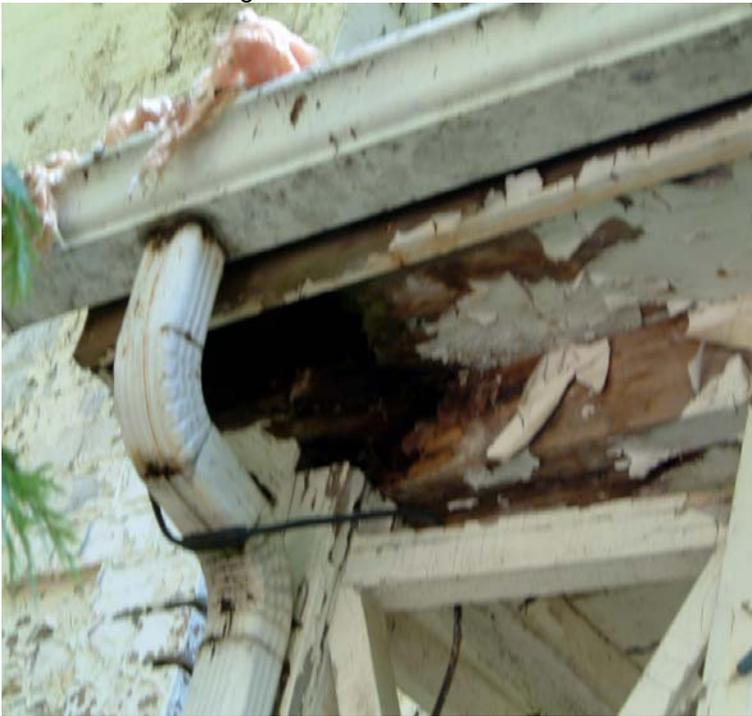
Damage to trimwork on west elevation
