## **COMMITTEE OF THE WHOLE – DECEMBER 6, 2011**

### **REQUEST FOR DEMOLITION OF DESIGNATED PROPERTY WITHIN THE WOODBRIDGE HERITAGE CONSERVATION DISTRICT, 197 WOODBRIDGE AVENUE, GARAGE/CARRIAGE STRUCTURE – WARD 2**

**Review of Building Structure  
197 Woodbridge Ave  
Woodbridge, Ontario**

Doctor McLean Carriage House  
197 Woodbridge Ave. Vaughan

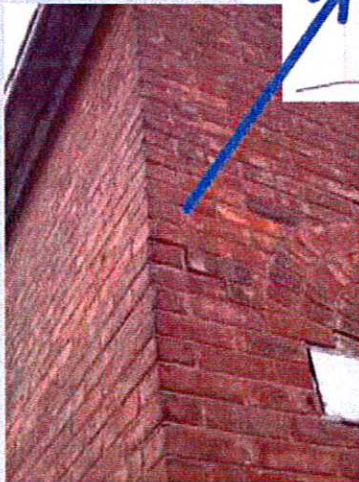
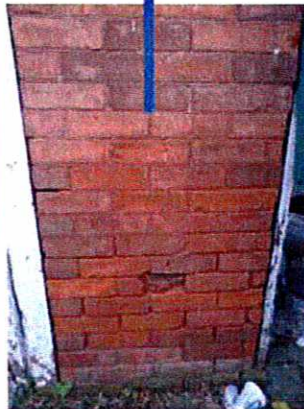
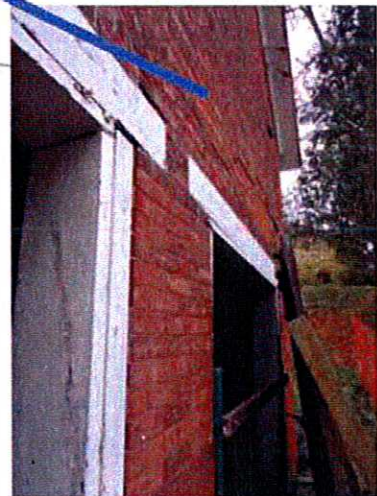
NORTH ELEVATION - 197 WOODBRIDGE AVENUE

## Building Front

Considerable brick deterioration due to wall shifting and frost action.

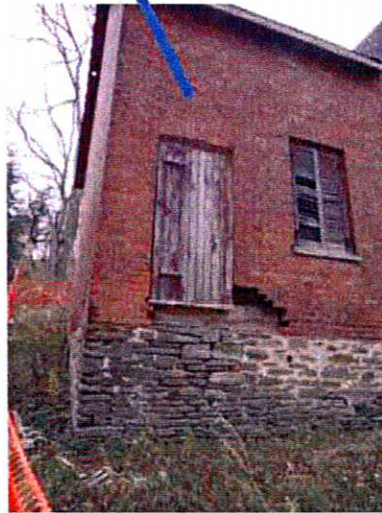
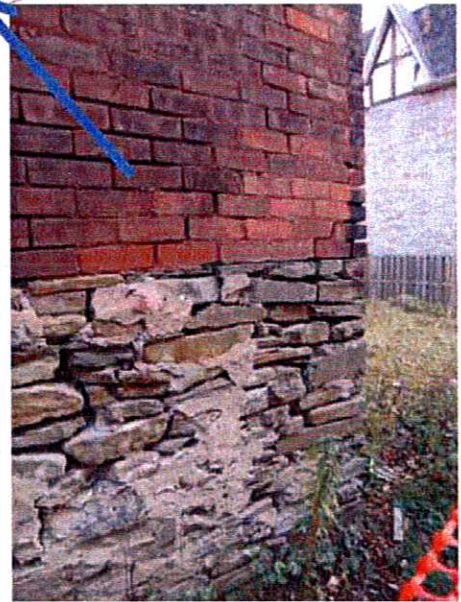
EAST ELEVATION - 197 WOODBRIDGE AVENUE

## East Elevation

Considerable deterioration of stone foundation wall and upper brick cladding due to wall shifting and frost action.

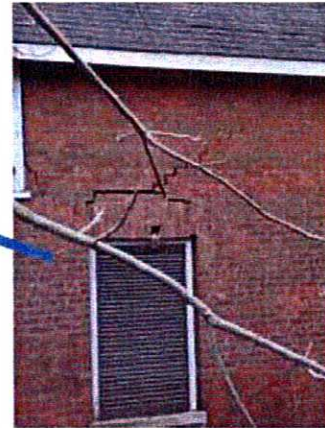
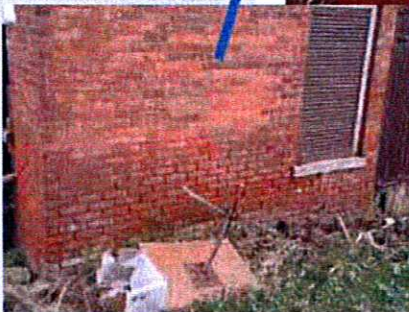
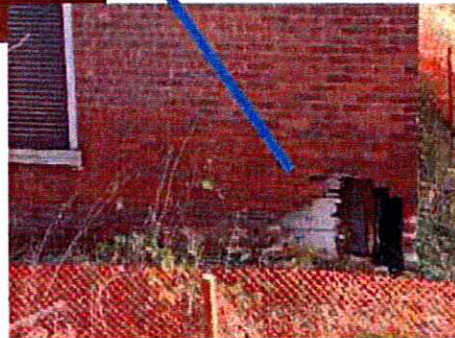
WEST ELEVATION - 197 WOODBRIDGE AVENUE

## West Elevation

Considerable deterioration of brick cladding due to wall shifting and frost action.

Caving of roof structure due to the above and to wood structure decay.

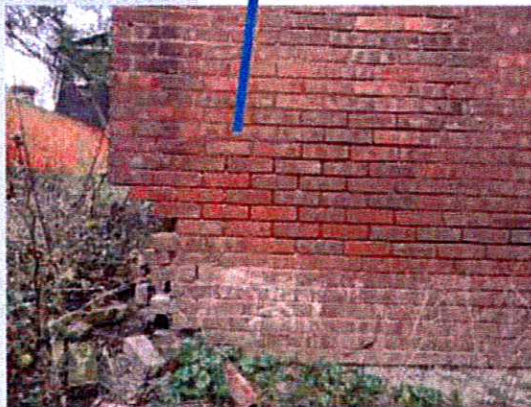
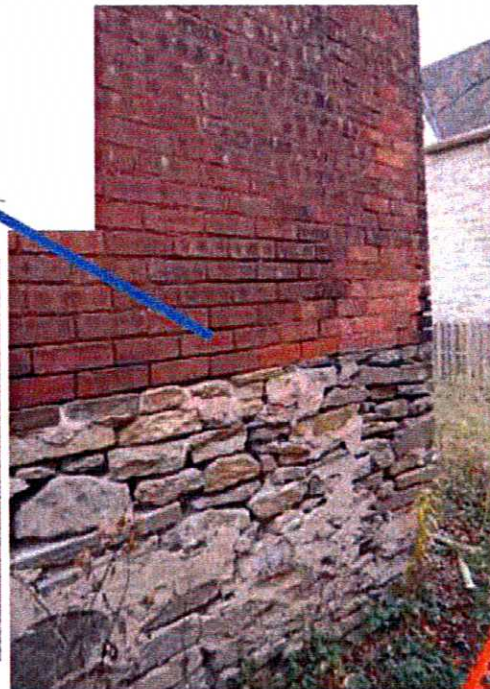
SOUTH ELEVATION - 197 WOODBRIDGE AVENUE

## South Elevation

Similar evidence of stone and deterioration of brick cladding, consistent with the other walls.

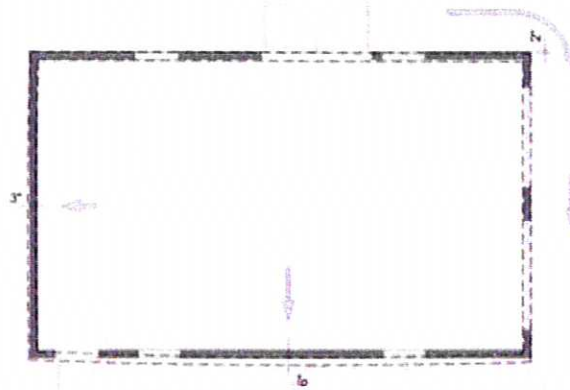
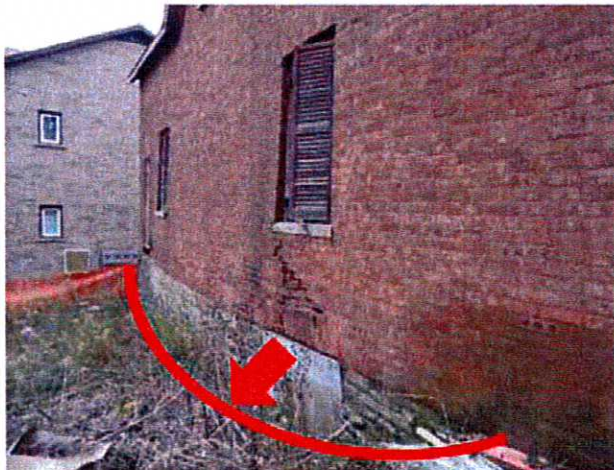
GENERAL PLAN - 197 WOODBRIDGE AVENUE

## Shift of Building

Note: Severe (180mm) displacement of the brick masonry and the stone foundation wall

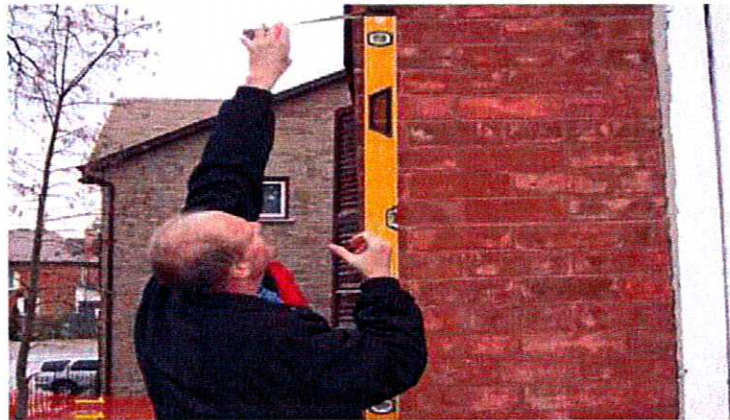
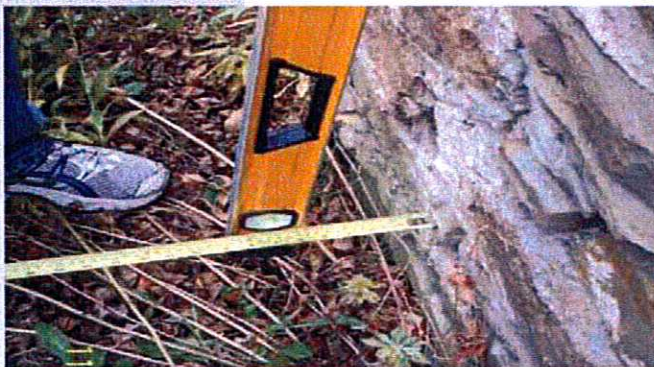
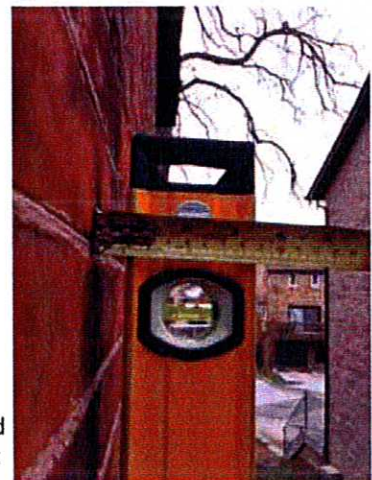
## Wall Displacement

East Wall has been displaced  
at least 180mm from its original  
vertical line

NE corner of the building has  
been displaced 22mm over 1.2m  
or 84mm over the height (4.6m)  
of the building to the lower ridge.

Structure along South Wall has been displaced  
by 20mm over 1.2m or 77 mm over the height  
of the structure to the overhang

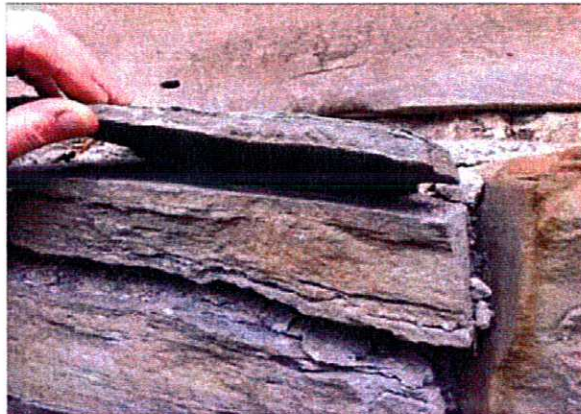
### Stone Masonry:

Deteriorated Shale  
Stone Masonry Unit  
Separating into Layers

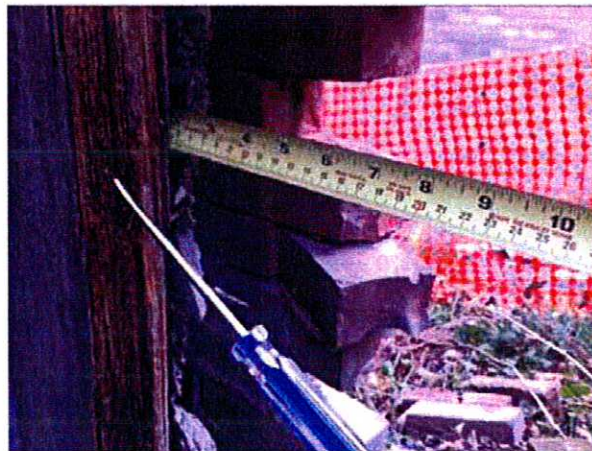
### Dry Rot in Wood Framing:

Framing member should  
be rough cut to 100mm  
(i.e. 50mm of member has  
rotted away).

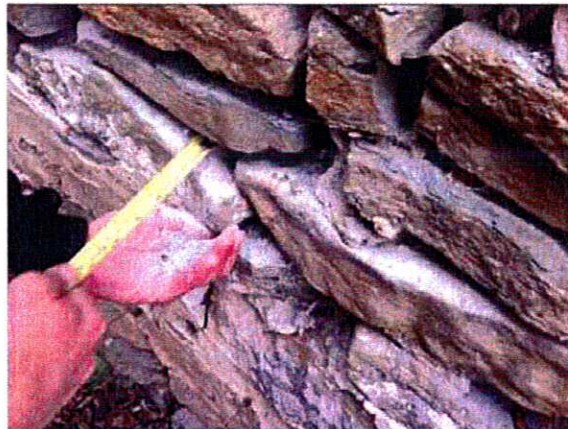
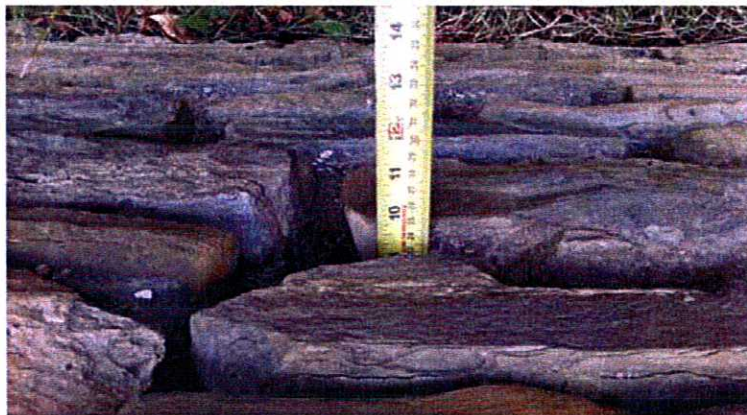
## Stone Foundation Wall

Completely deteriorated  
Mortar being removed  
from Wall.

Note: Deteriorated mortar  
at least 250mm at south  
east corner

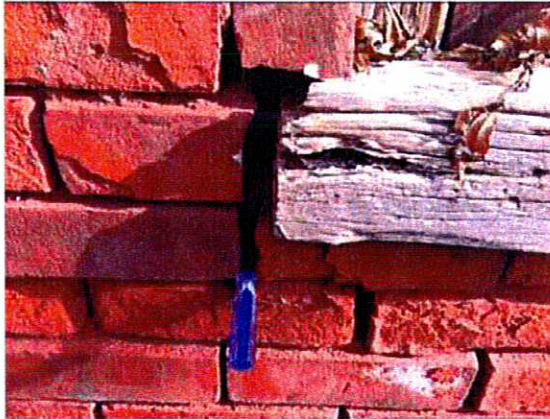
### Brick Deterioration

An example of the extent of the brick masonry deterioration (i.e. the full width of the brick).

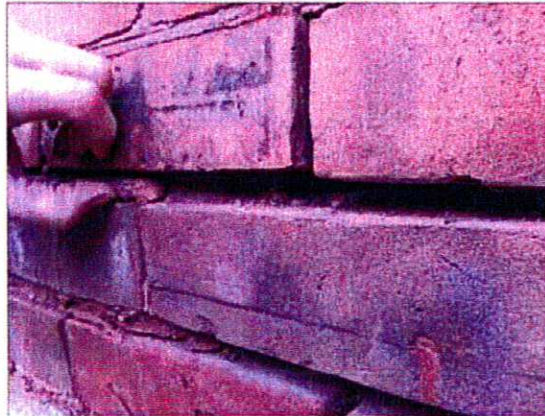
Note:  
Deteriorated brick masonry  
mortar easily removed by hand

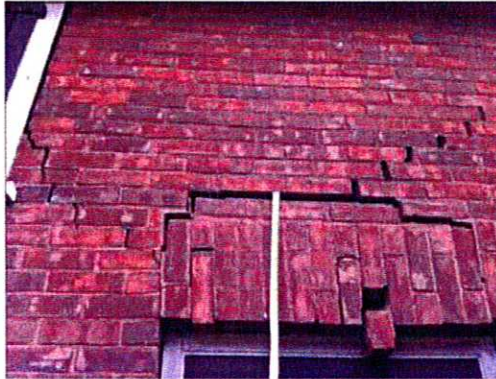
### West Wall:

Note: Severe displacement of brick masonry and failed brick header above window on west side of building

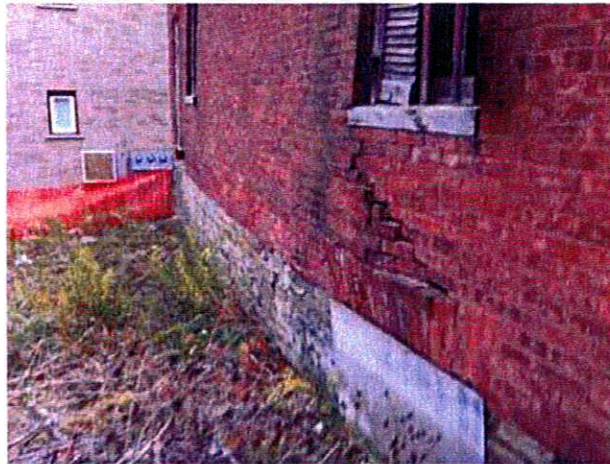
### East Wall:

Note: Severe (180mm) displacement of the brick masonry and the stone foundation wall

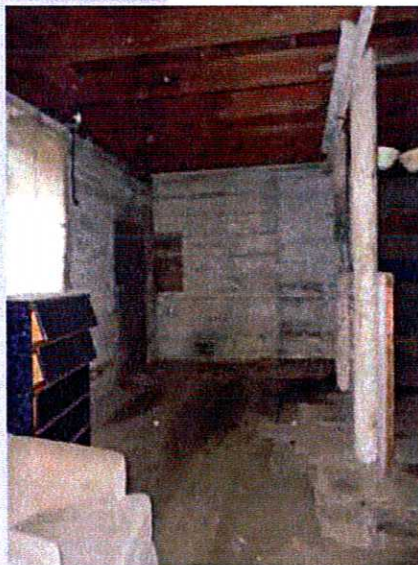
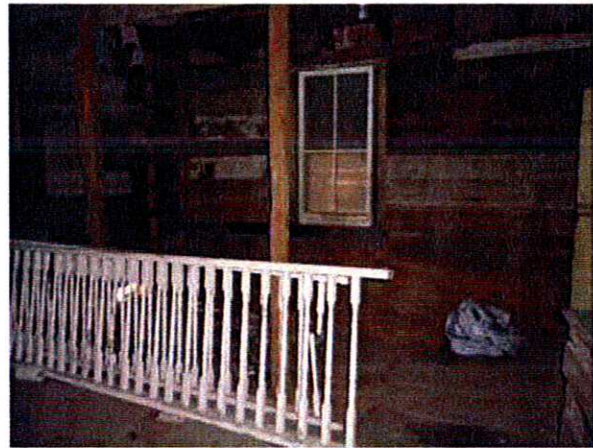
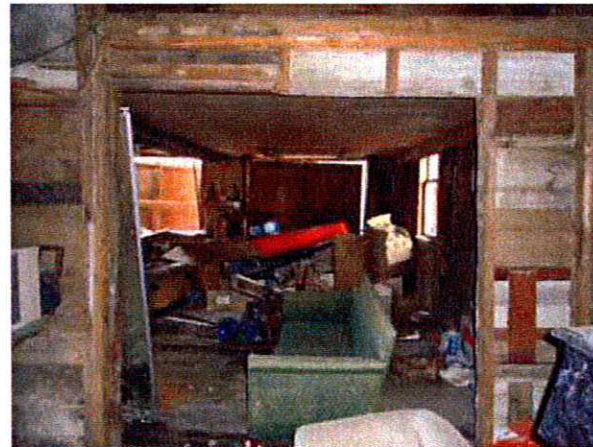
## Building Interiors

Severely Water Stained Sheathing at outer walls.

Note: Extensive water damage  
Deterioration the wood cladding and  
structure and extensive presence of mould.

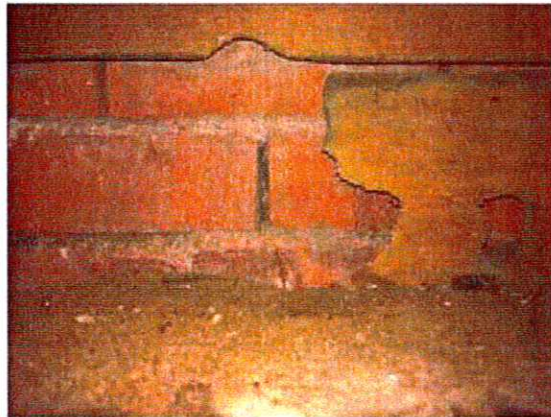
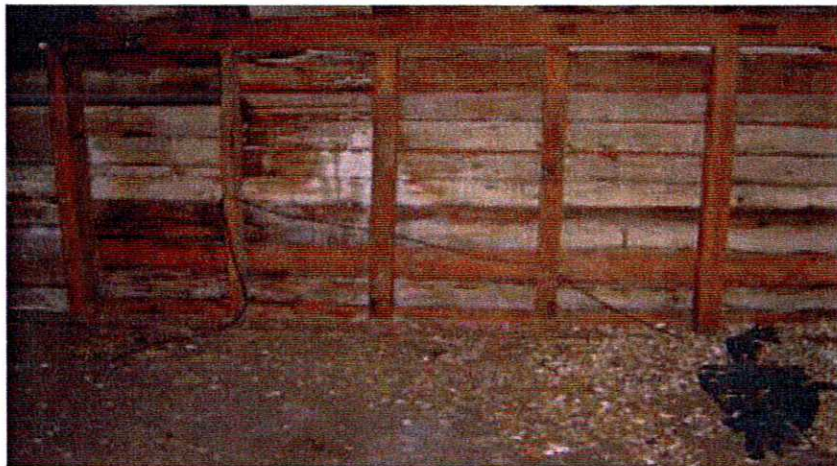
## Rotted Wall Sheathing

Severely Water Stained Sheathing

Note: Dry Rot in Wall Sheathing at  
second floor level- West Elevation

Note:

Severe Water Stained  
Sheathing in direct  
contact with  
structural framing

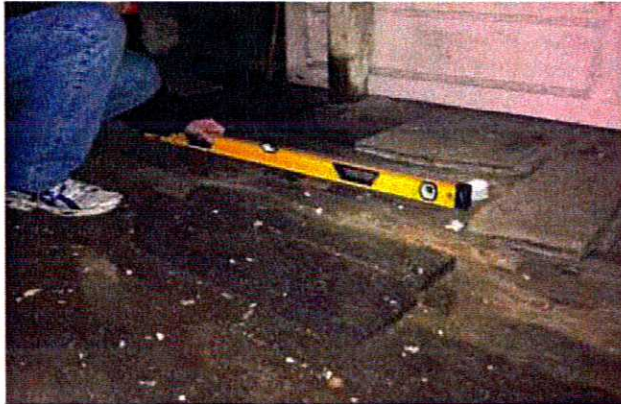
#### Sagging Floor in SE Quadrant

### Sagging structure of Main Floor

Note: Sections of Wood  
Flooring added to fill in  
sagged areas of the  
flooring

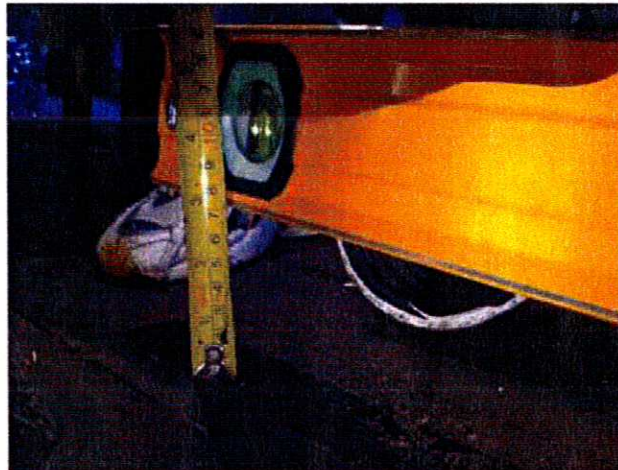
#### Sagging of Failed Floor Joists at NE Quadrant

Note: Sagging Floor Boards  
resulting from floor joists  
slipped off foundation wall-  
Measured deflections  
represent 75mm over 1.2m or  
230mm between supported  
ends of joists.

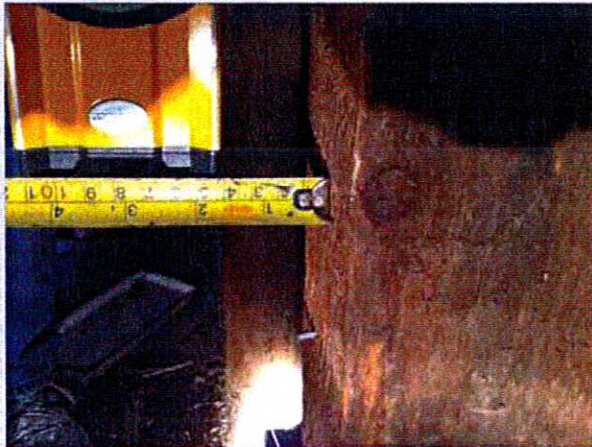
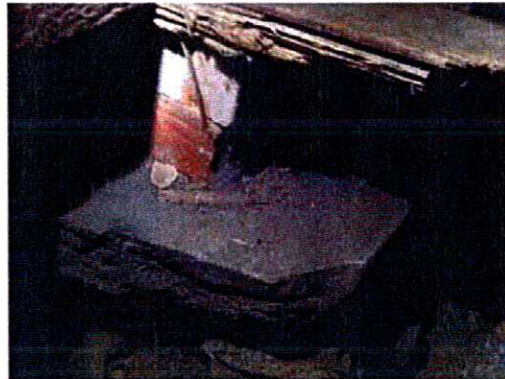
## Building Displacement

East Wall Wood Framing has been displaced approximately 175mm over the height of the building to the lower ridge

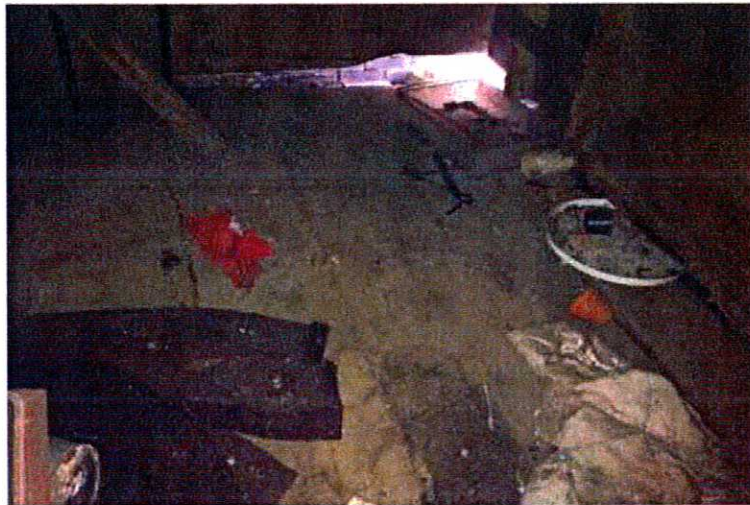
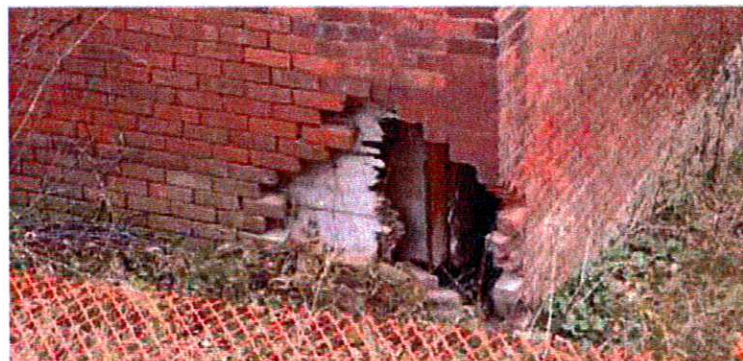
## Intermediate Pier Construction

Poorly Constructed Intermediate Pier consisting of stacked single width brick and stone slabs without any mortar

## Flooring Structural Condition

### Main Floor:

Unsupported Flooring  
in SW Quadrant

Note: Unsupported  
condition present at  
the SW corner of the  
building

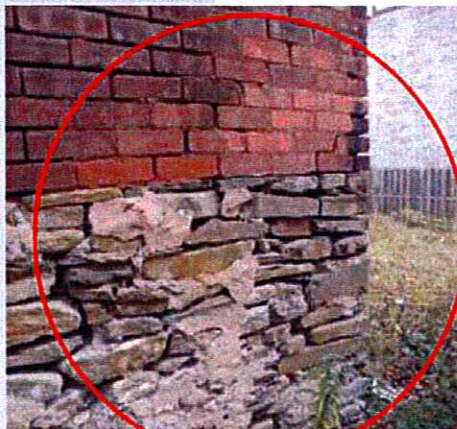
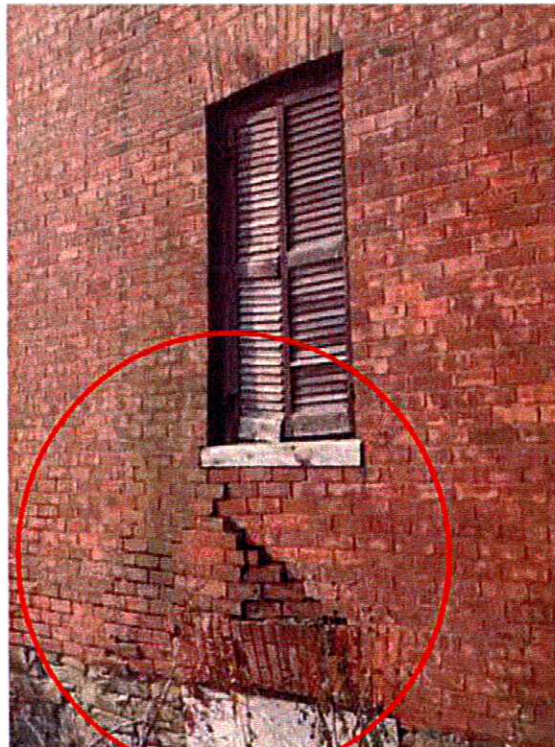
## Summary of Findings

Severe Displacement of building

- Building **Rotating** off its stone foundation
- Stone foundations- **Unreinforced**- Unable to resist rotation- essentially have failed
- Displacement has caused building to be Very **Unstable** and **Unsafe**
- Main floor has become **Unsupported** in Several Areas and thus Unstable
- Intermediate Piers beneath Main Floor are **inadequately** constructed and Unstable
- Wood Rot** Evident in the Structural Framing
- Extensive Water Penetration & **Mould** on Sheathing making structural framing suspect
- Brick Masonry Cladding –literally **tearing apart** from the displacement of the building
- Extensive **deterioration** readily visible in the stone foundation & brick masonry
- Shifting** of building has lead to openings to become out of true
- Existing building **does not meet current occupancy and safety standards**

### Probable causes of Building Failure

Most probable cause of building failure is soil and hydrostatic load acting against the unreinforced west and north foundation walls of the building in combination with frost action.

Wind loading and seismic activity may have had some negative effect on the building as well.

## Recommendations

- Building is **very unstable** and thus **unsafe** to general public and users of the building.
- Rehabilitation of the building will require the **complete dismantling** of the building to re construct and reinforce the foundation walls, intermediate piers, re-support & re-construct the main floor, re-construct the structural framing, sheathing, brick masonry, window and door framing and roof coverings.

- Given the extent of the building damages and the fact that no part of the structure, from the foundation walls to the roofing can be preserved, the **restoration** of the building and its rehabilitation to present standards is **not technically possible**. The substitution of the stone, bricks, wood walls and flooring and roof structure will defy the purpose of historical preservation and architectural conservation.

- Based on the above, it is our professional opinion that, for the safety of neighbours and the general public, the **building be demolished** in a timely manner.
