## COMMITTEE OF THE WHOLE – APRIL 24, 2012

### REQUEST FOR DEMOLITION OF THE GARAGE/CARRIAGE HOUSE STRUCTURE, 197 WOODBRIDGE AVENUE – WARD 2

**RE: Peer Review of the Report  
“Doctor McLean Carriage House, 197 Woodbridge Ave., Vaughan”  
Prepared by Nino Rico Architect and REMY Consulting Eng.**

Doctor McLean Carriage House  
197 Woodbridge Ave., Vaughan

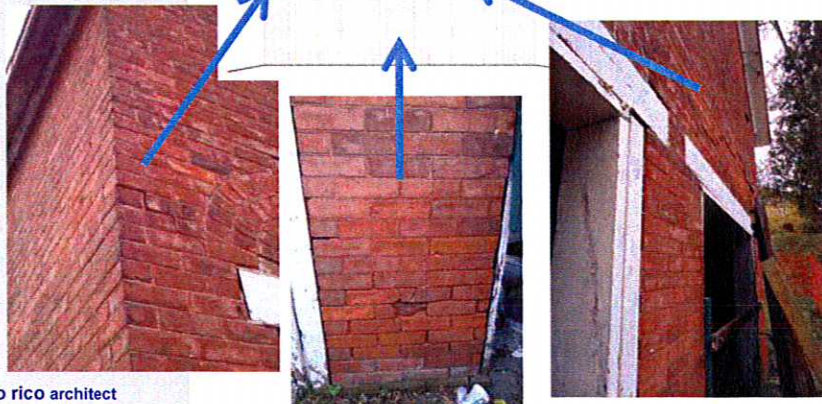
NORTH ELEVATION - 197 WOODBRIDGE AVENUE

Considerable brick deterioration due to wall shifting and frost action.

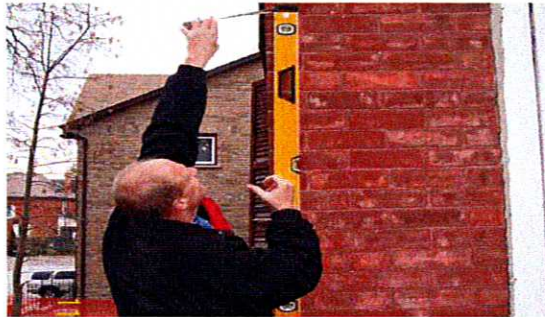
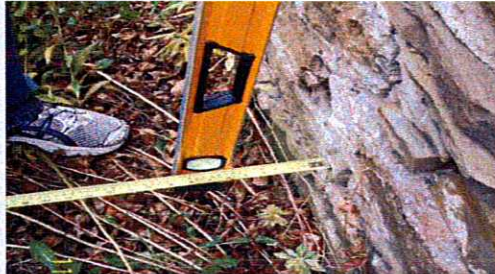
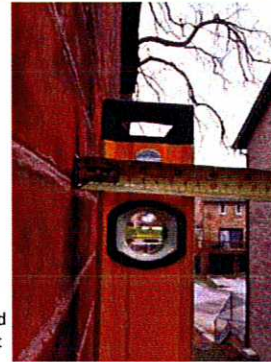
### Wall Displacement

East Wall has been displaced at least 180mm from its original vertical line

NE corner of the building has been displaced 22mm over 1.2m or 84mm over the height (4.6m) of the building to the lower ridge.

Structure along South Wall has been displaced by 20mm over 1.2m or 77 mm over the height of the structure to the overhang

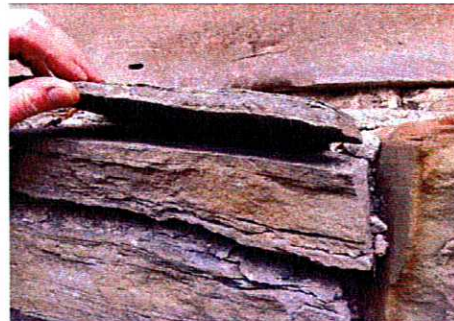
Deteriorated Shale  
Stone Masonry Unit  
Separating into Layers

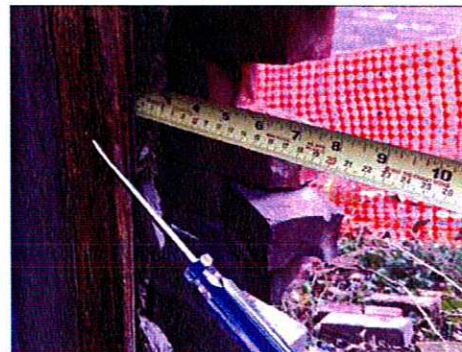
#### Dry Rot in Wood Framing:

Framing member should be rough cut to 100mm (i.e. 50mm of member has rotted away).

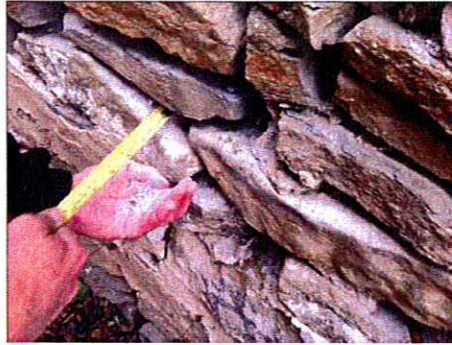
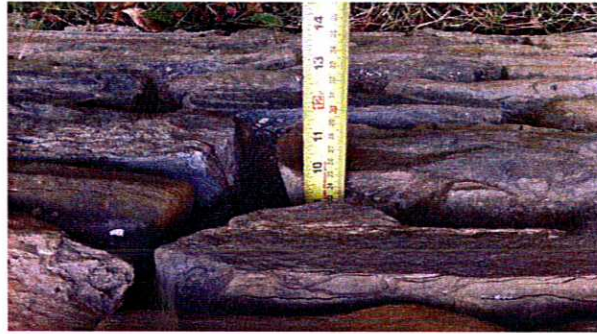
### Stone Foundation Wall

Completely deteriorated Mortar being removed from Wall.

Note: Deteriorated mortar at least 250mm at south east corner

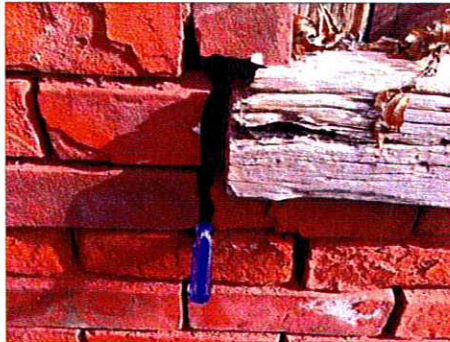
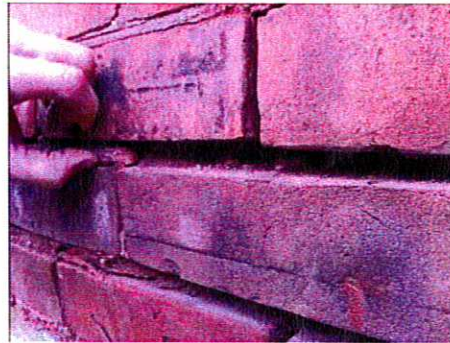
### Brick Deterioration

An example of the extent of the brick masonry deterioration (i.e. the full width of the brick).

Note:  
Deteriorated brick masonry mortar easily removed by hand

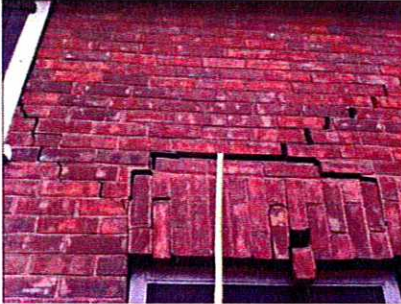
**West Wall:**

Note: Severe displacement of brick masonry and failed brick header above window on west side of building

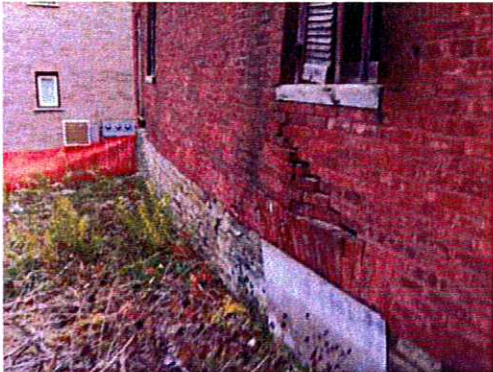
**East Wall:**

Note: Severe (180mm) displacement of the brick masonry and the stone foundation wall

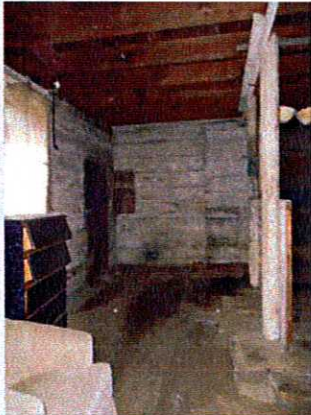
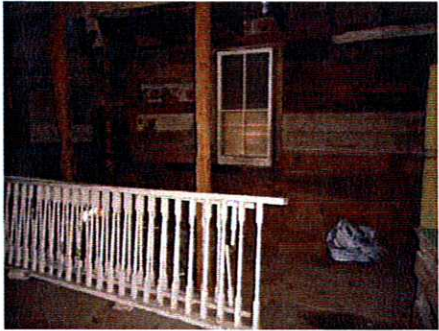
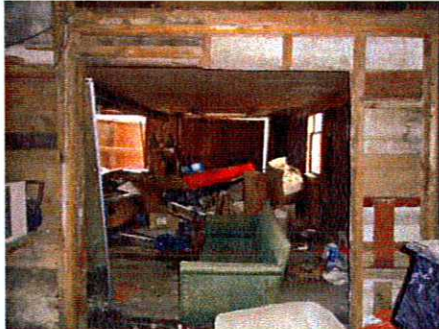
### Building Interiors

Severely Water Stained Sheathing at outer walls.

Note: Extensive water damage  
 Deterioration the wood cladding and structure and extensive presence of mould.

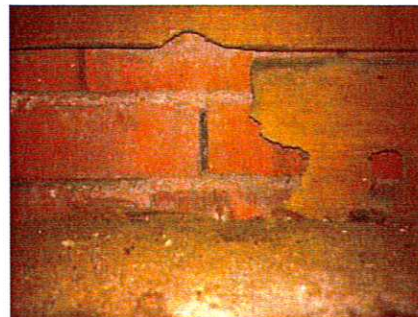
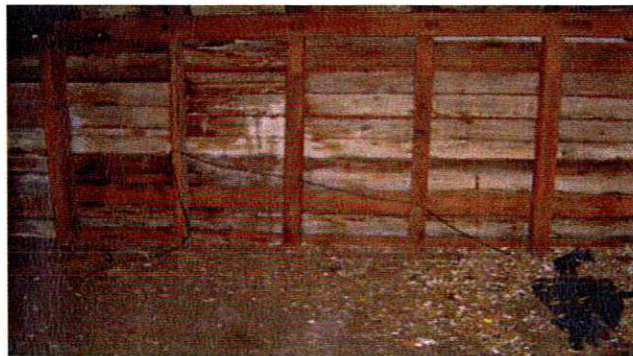
## Rotted Wall Sheathing

Severely Water Stained Sheathing

Note: Dry Rot in Wall Sheathing at second floor level- West Elevation

Note:  
Severe Water Stained Sheathing in direct contact with structural framing

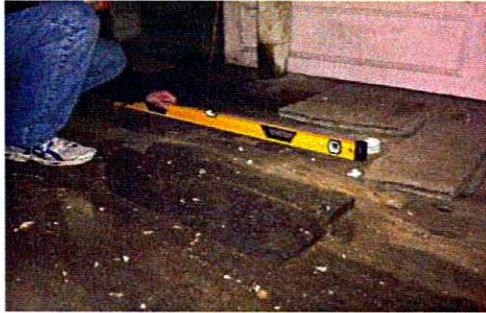
#### Sagging Floor in SE Quadrant

Note: Sections of Wood Flooring added to fill in sagged areas of the flooring

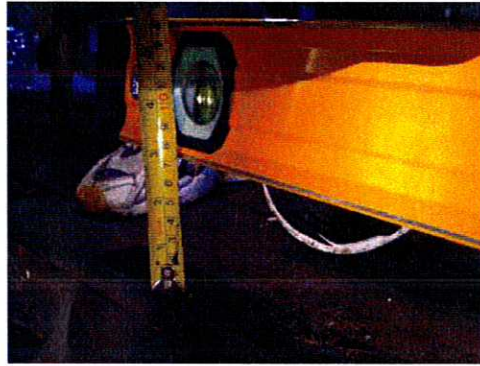
#### Sagging of Failed Floor Joists at NE Quadrant

Note: Sagging Floor Boards resulting from floor joists slipped off foundation wall- Measured deflections represent 75mm over 1.2m or 230mm between supported ends of joists.

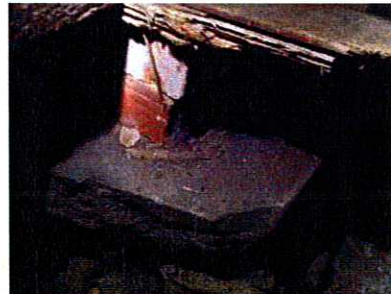
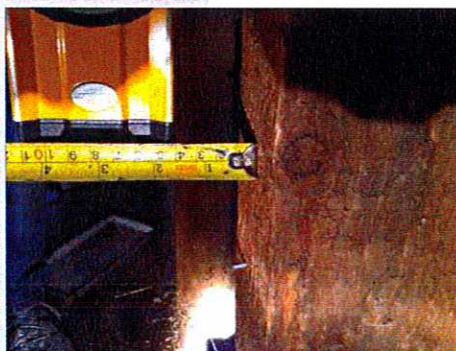
### Building Displacement

East Wall Wood Framing has been displaced approximately 175mm over the height of the building to the lower ridge

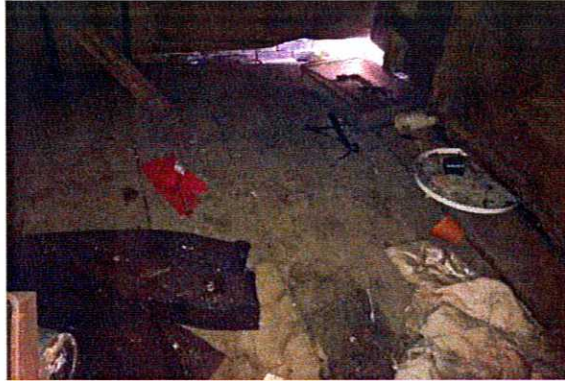
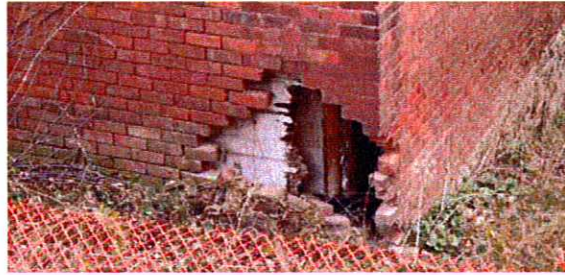
Unsupported Flooring in SW Quadrant

Note: Unsupported condition present at the SW corner of the building

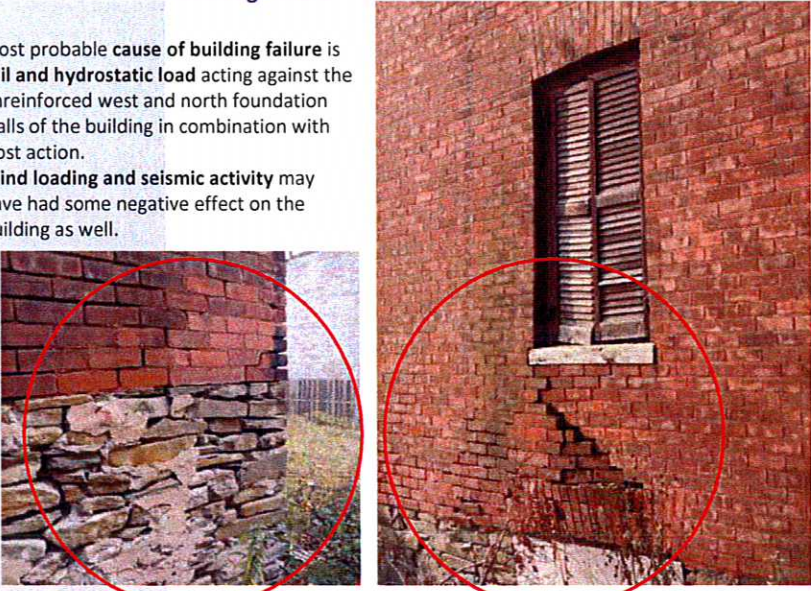
### Probable causes of Building Failure

Most probable cause of building failure is soil and hydrostatic load acting against the unreinforced west and north foundation walls of the building in combination with frost action.

Wind loading and seismic activity may have had some negative effect on the building as well.

- Based on the above, it is our professional opinion that, for the safety of neighbours and the general public, the **building be demolished** in a timely manner.
