HERITAGE VAUGHAN COMMITTEE

AGENDA

June 20, 2012

1. 10773 HUNTINGTON ROAD – HERITAGE REVIEW OF NEWLY CONSTRUCTED GARAGE, SHED AND COVERED PORCH – WARD 1

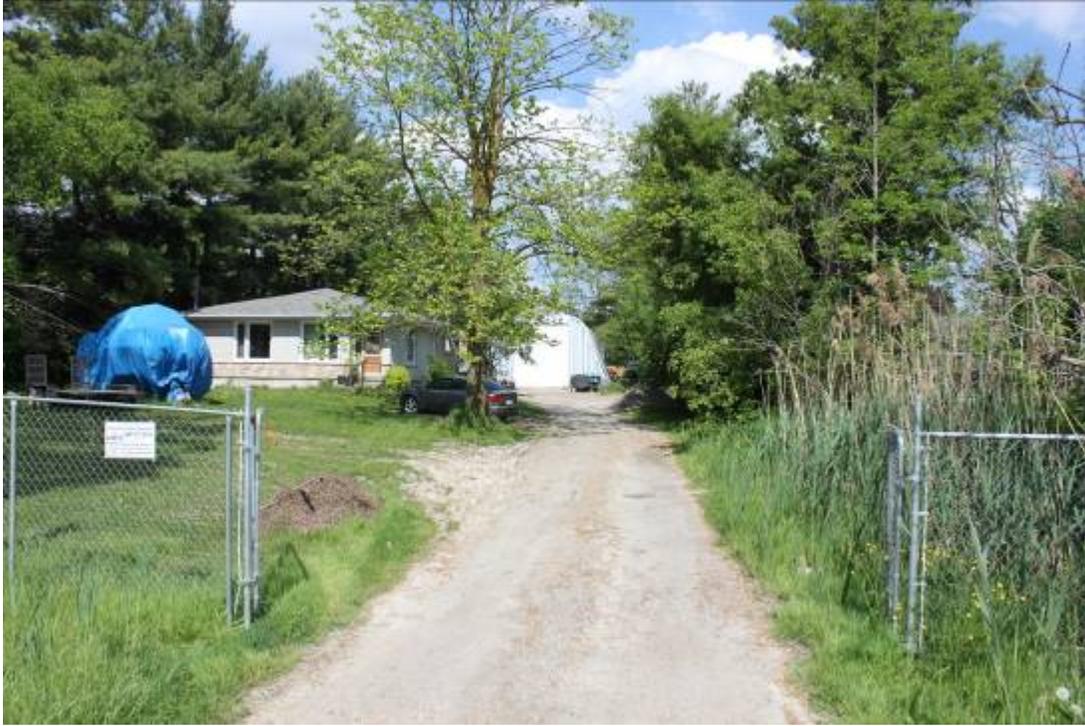
Cultural Services found that of the three proposed structures, the galvanized metal garage is very visible from Huntington Road. Although it is considerably set back from the street it still impacts the streetscape and it detracts from the heritage character that the district aims to maintain. The structure is approximately 121 metres squared in footprint area. Its height is noted at 5.48 metres in the drawings accompanying the Committee of Adjustment application. The area exceeds the permitted accessory building coverage by 54 sq. metres and the permitted height by 1.08 metres.

Fig. 2. May 24, 2012 Site Visit - 10773 Huntington Road. Photo by Cultural Services. View from Huntington Road.

3. That Heritage Vaughan approve the retention of the prefabricated metal garage structure with the following conditions:
 - a. That the applicant work with Cultural Services to provide appropriate screening of the prefabricated metal garage structure from Huntington Road in the way of or similar to tall evergreen plantings along the front of the property line, and;

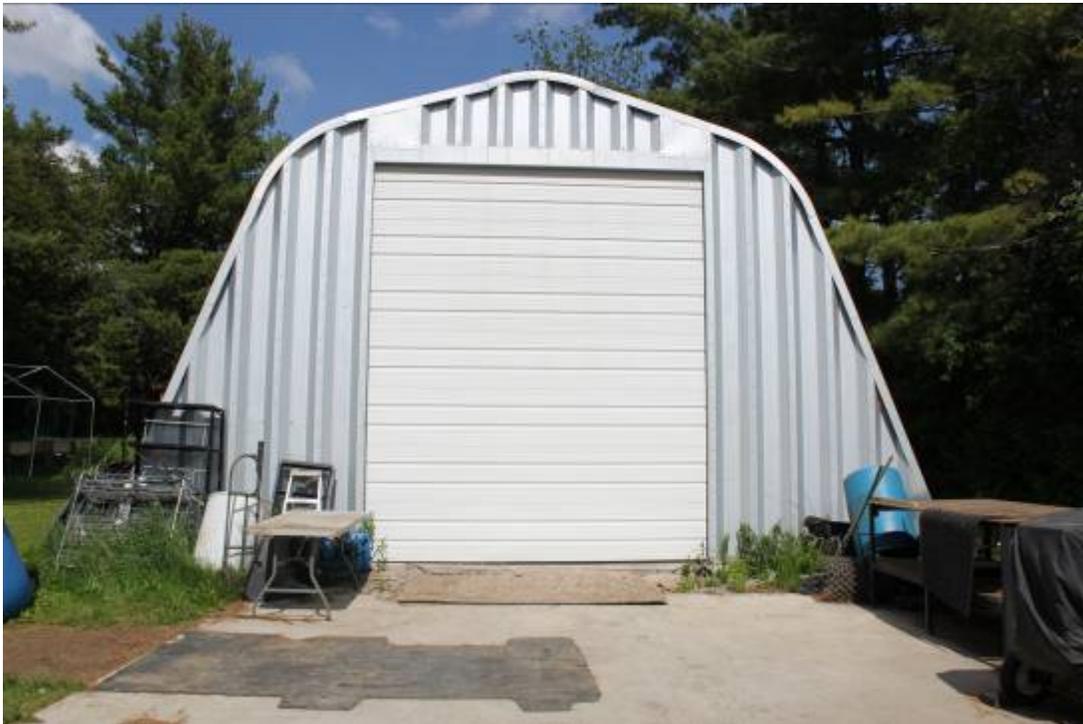
Fig. 3. May 24, 2012 Site Visit - 10773 Huntington Road. Photo by Cultural Services. Garage, front view.

- b. That Heritage Vaughan approve the design for the façade of the garage structure as presented in the drawings dated June 5, 2012, and;
 - c. That the façade, doors and details be constructed of wood or suitable equivalent as reviewed and approved by Cultural Services staff, and;

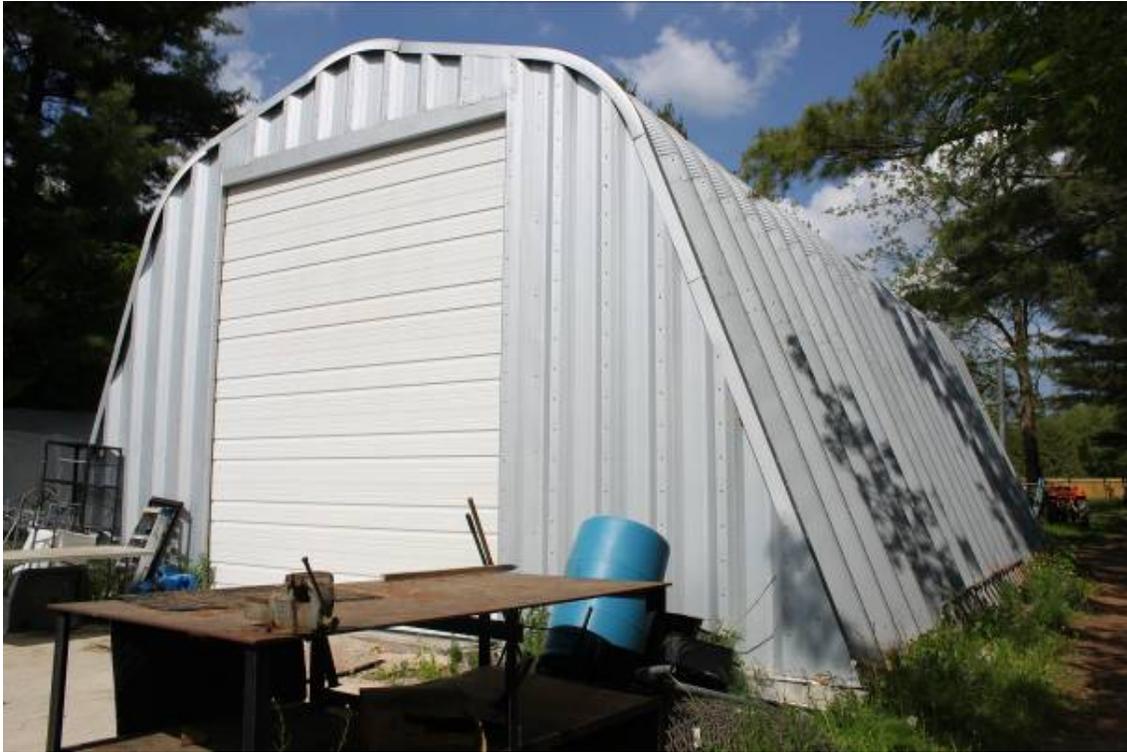
Fig. 4. May 24, 2012 Site Visit - 10773 Huntington Road. Photo by Cultural Services. Garage.

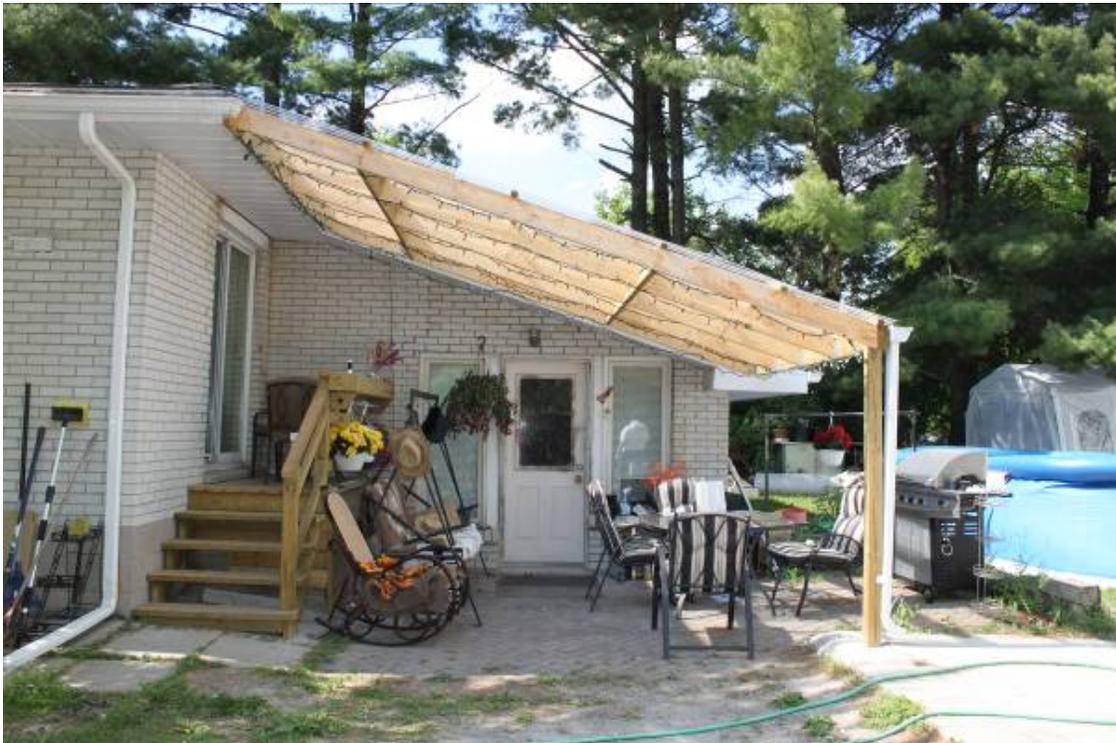
The other two proposed structures proposed for retention are the red wood clad shed and the covered porch area to the rear of the main house. These two structures are not readily seen from the streetscape nor does their setback affect any neighbours directly to the south, who are within the Heritage District. The coverage of the red clad structure exceeds the allowable for the property in its entirety. The structure is located closer to the North boundary of the property, away from the other neighbours within the Heritage Conservation district and is one level tall (4.04m). The covered porch area has not been identified as a variance.

Cultural Services recommends that the retention of the covered porch structure and the red shed structure does not impact the Heritage District Streetscape.

Fig. 5. May 24, 2012 Site Visit - 10773 Huntington Road. Photo by Cultural Services. Covered porch at back of main house.

2. That since Huntington Road, is predominantly rural in character, Cultural Services recommends that Heritage Vaughan approve the shed and covered porch structures as the property has a mid-century style house on it, these two structures are not seen from the streetscape, nor does their setback affect any neighbours within the Heritage District, and;

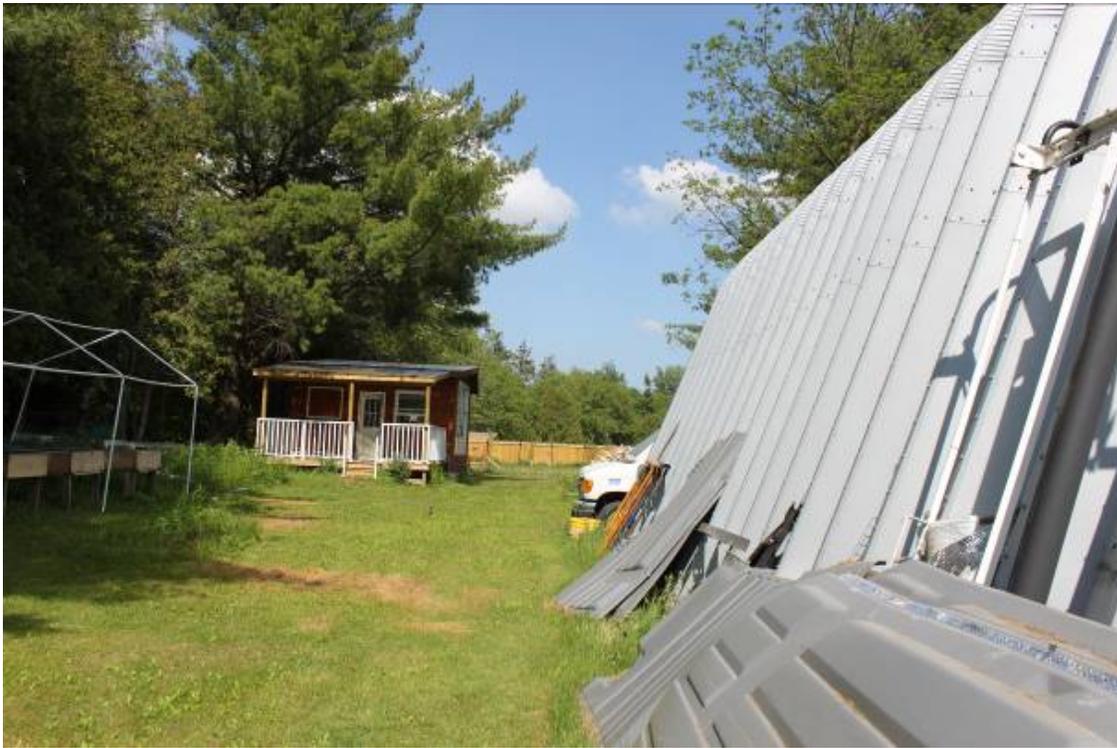
Fig. 6. May 24, 2012 Site Visit - 10773 Huntington Road. Photo by Cultural Services. Side of Garage, shed at left.

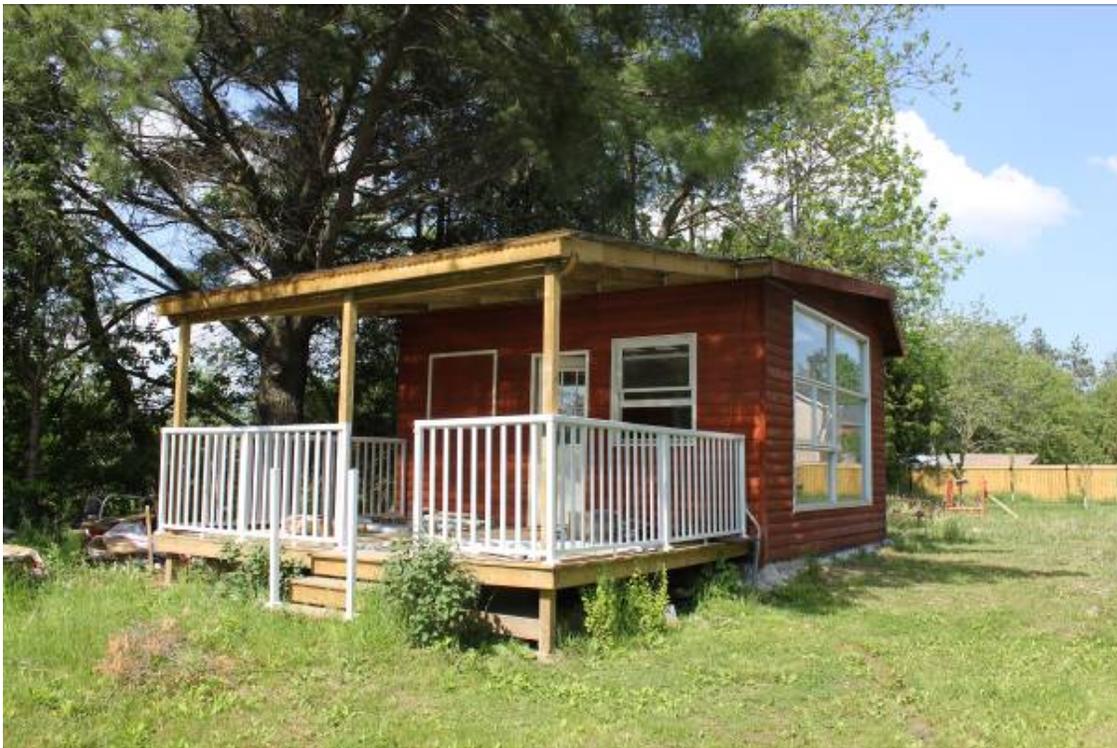
Fig. 7. May 24, 2012 Site Visit - 10773 Huntington Road. Photo by Cultural Services. Shed.

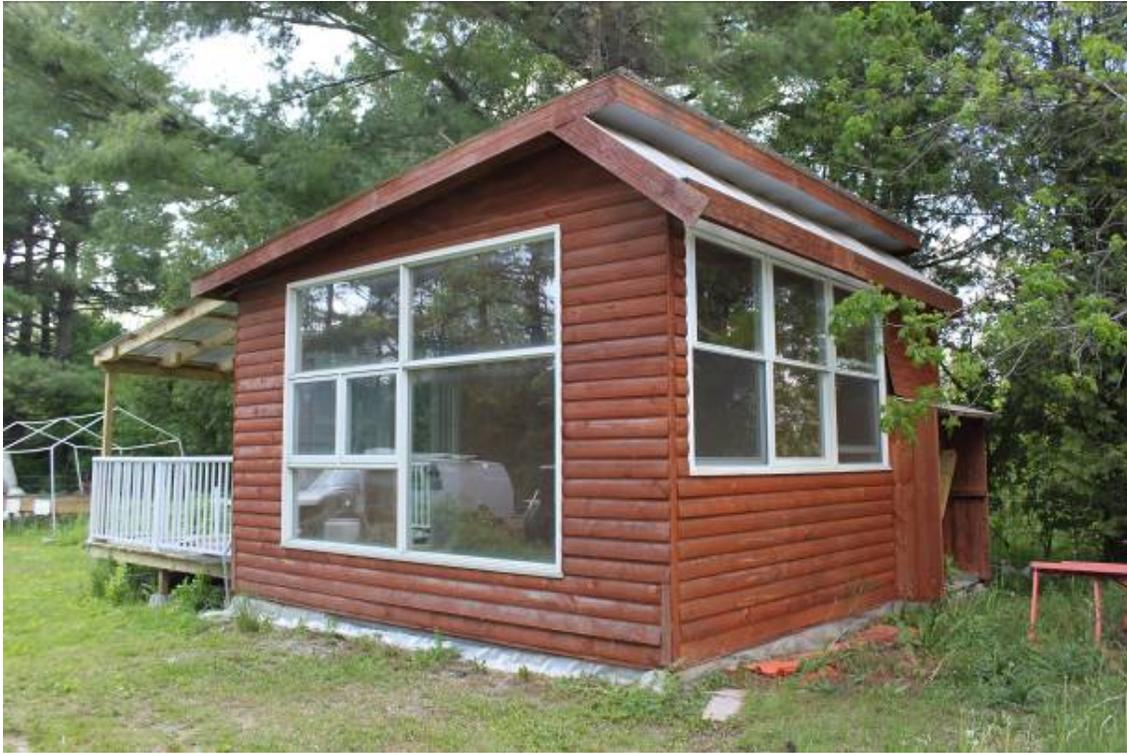
Fig. 8. May 24, 2012 Site Visit - 10773 Huntington Road. Photo by Cultural Services. Shed.

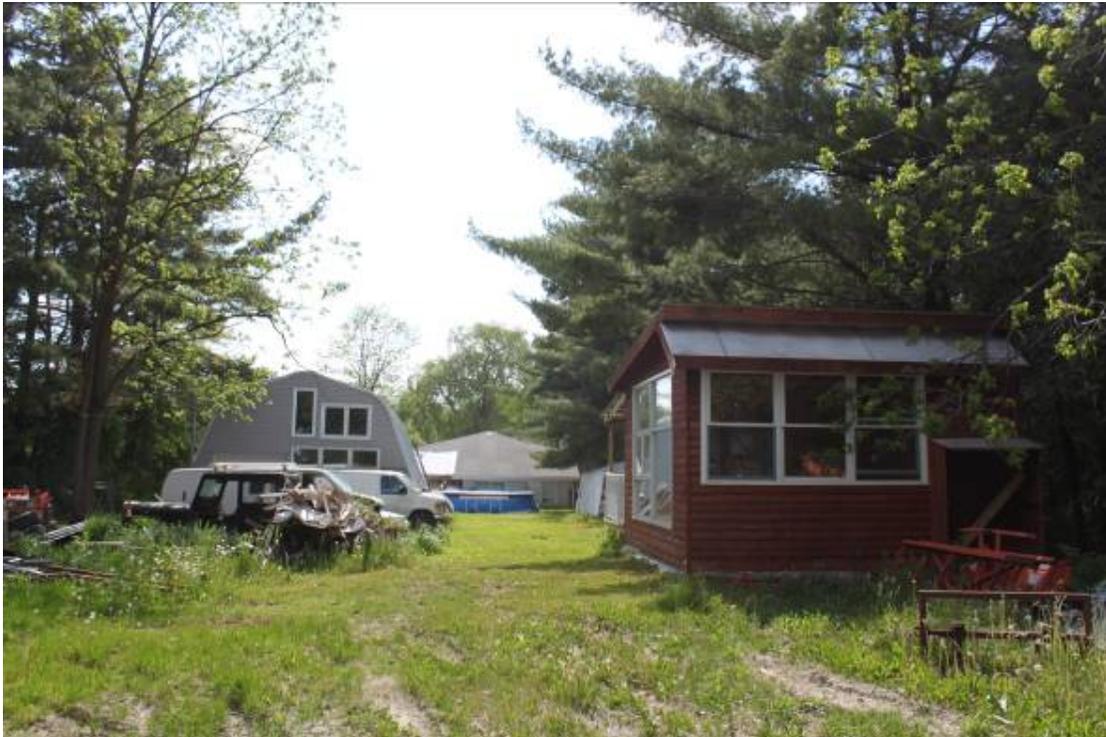
Fig. 9. May 24, 2012 Site Visit - 10773 Huntington Road. Photo by Cultural Services. View from the back of the property.

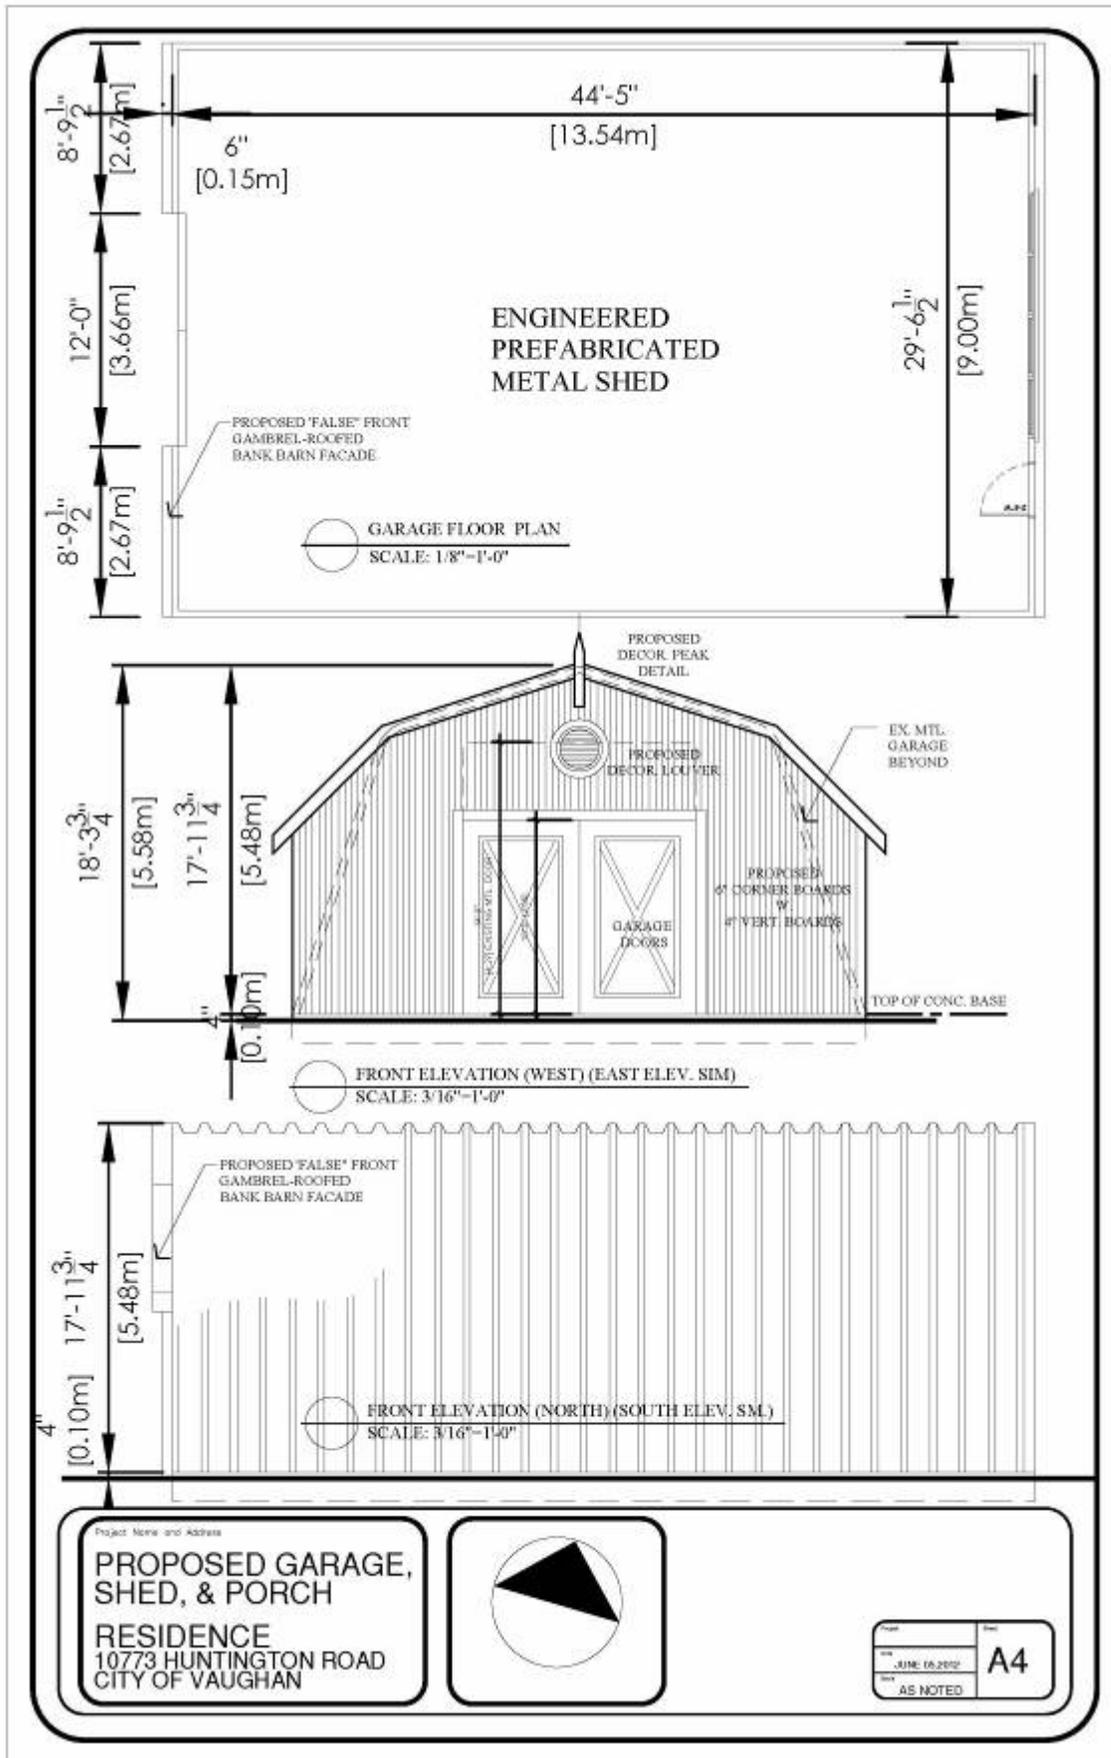
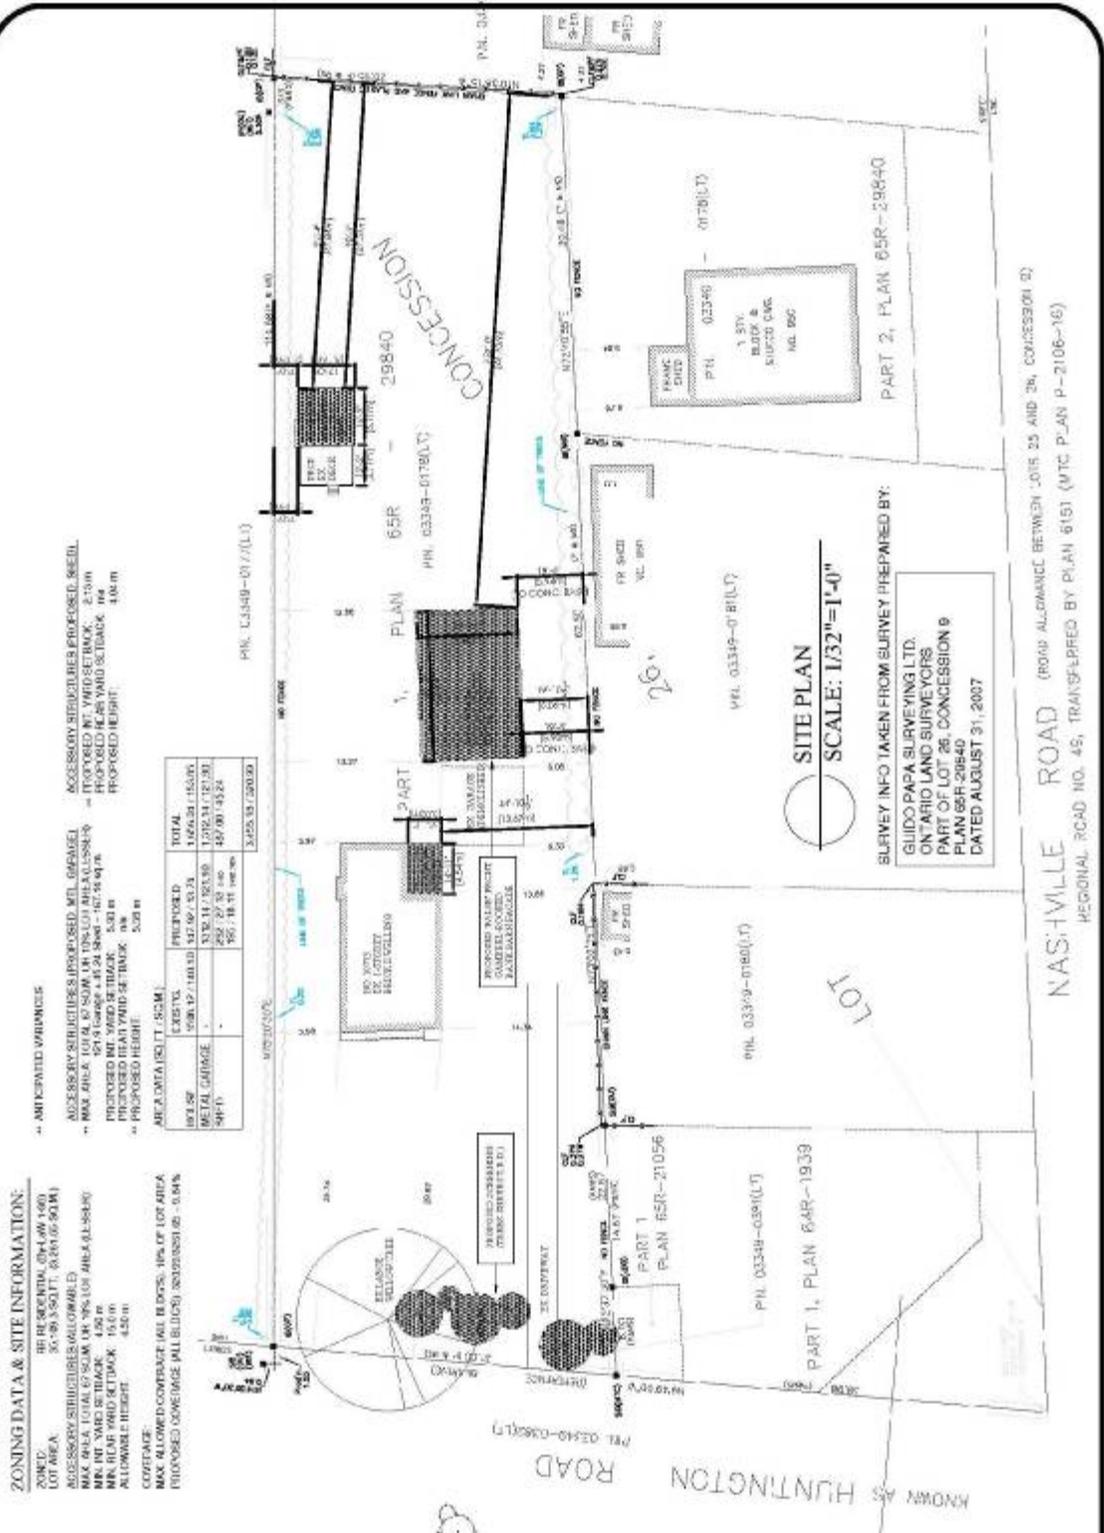
Fig. 10 and 11. Proposed façade and screening plantings respectively. June 5, 2012.

Cultural Services reviewed the proposed work to the façade of the steel garage structure and the proposed planting plan received on June 5, 2012. The applicant proposed to paint the garage structure and if that was found not to be sufficient, the façade structure could be erected. Cultural Services finds that painting the garage structure would not help the impact of its style. Although the façade treatment for the garage would not have been recommended as an approach if staff had had the chance to work with the applicant prior to the structure being permanently built. Cultural Services finds that these are acceptable solutions at this time.

The solution involves applying the approach of historical conversion to the façade of the building, which is allowed under the guidelines. Since the garage is significantly set back, the façade is the part that mostly affects the district's character. The garage façade should be built in wood finishes, including the details and doors.

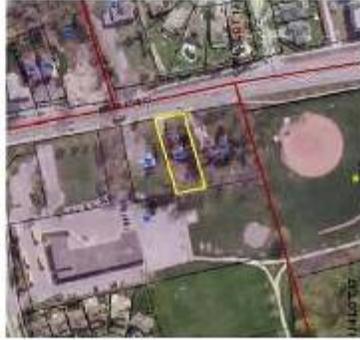
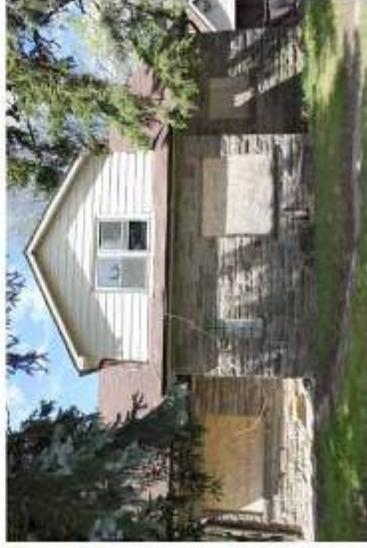
| CONDITION | EVALUATION CRITERIA | GRADING | COMMENTS |
|--|--|---|--|
| Exterior/interior of building is in good structural condition (i.e. evidence of decay in exterior siding, roof, or interior basement, wall surface, flooring, or ceiling, suggesting structure to be unsound). Checklist: Exterior Siding/Gutters (cracks, spalling) Roof/Interior Ceiling/Gutters Flooring, unstable, depressions Interior Wall surface, cracks, etc Basement (leaks mold, dry or wet rot on beams) | G- Good structural condition. (No evidence of decay) | G- 20 | The concrete block is separating from the rest of the structure at one location. Wildlife and possibly vandals have come into the building and made some holes in the walls. |

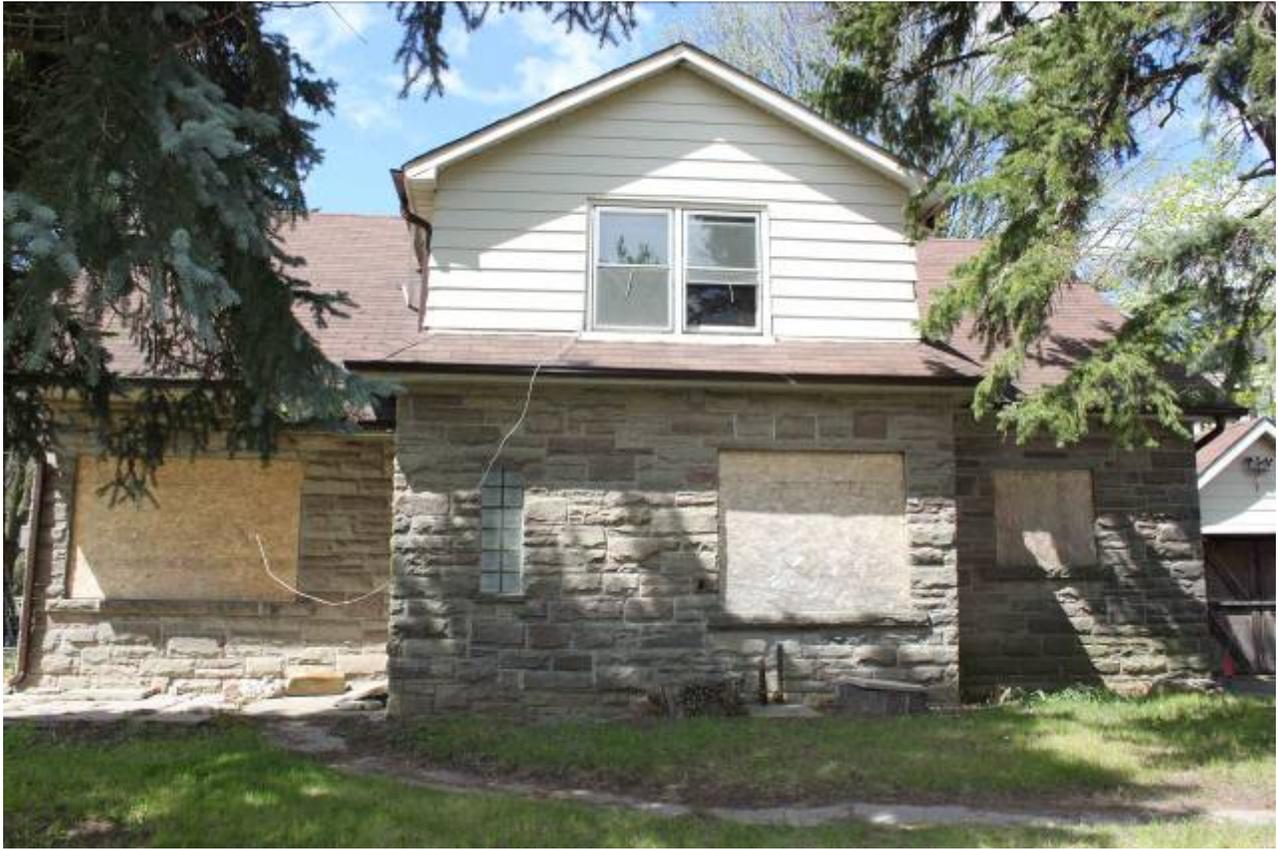
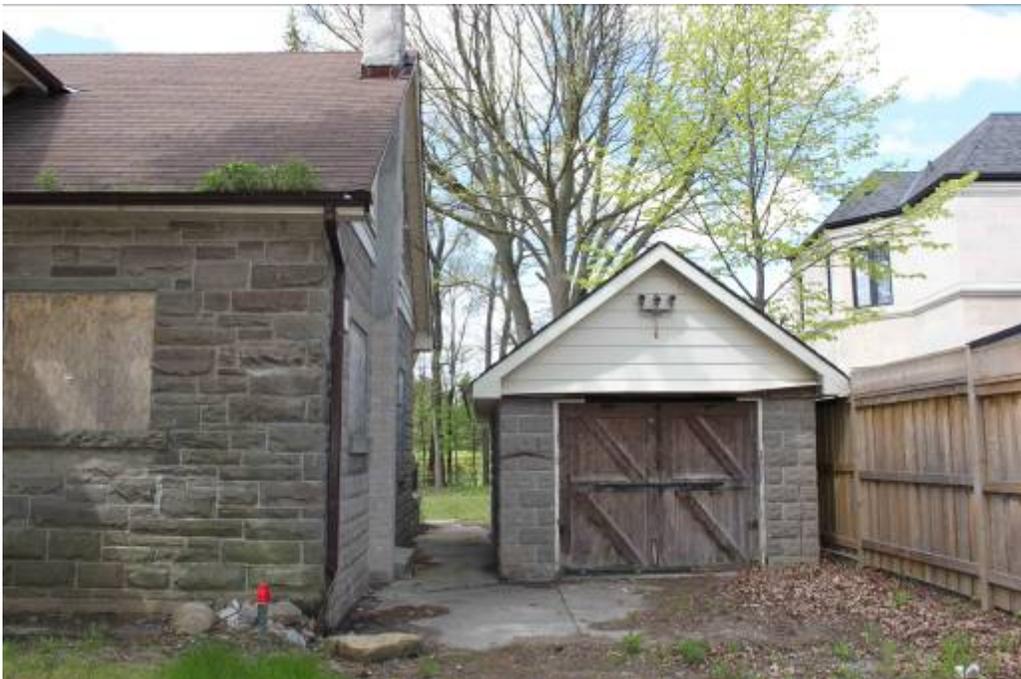
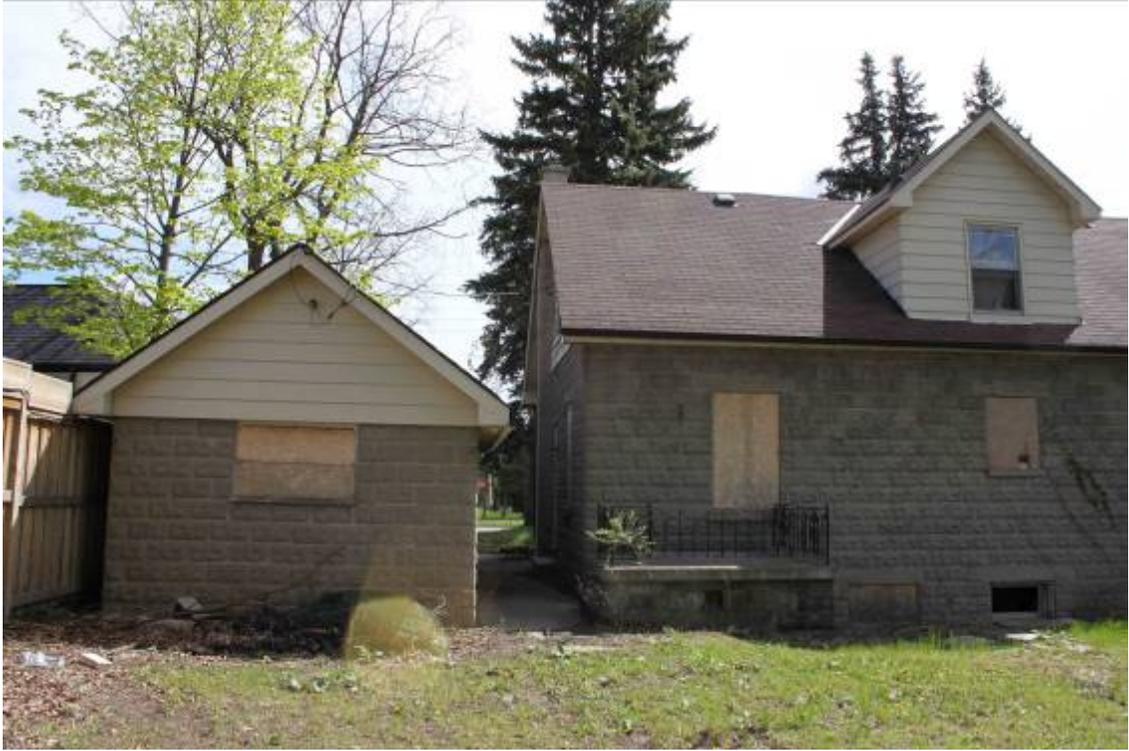
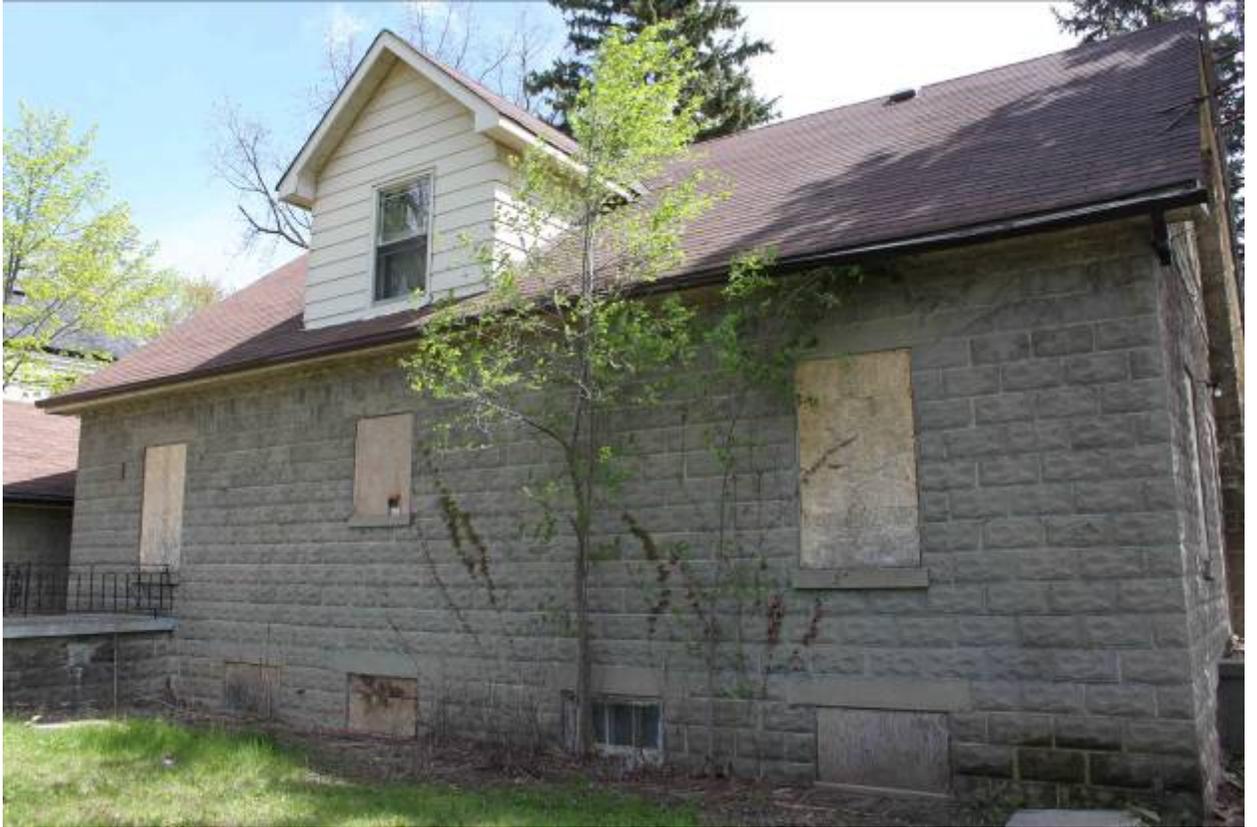
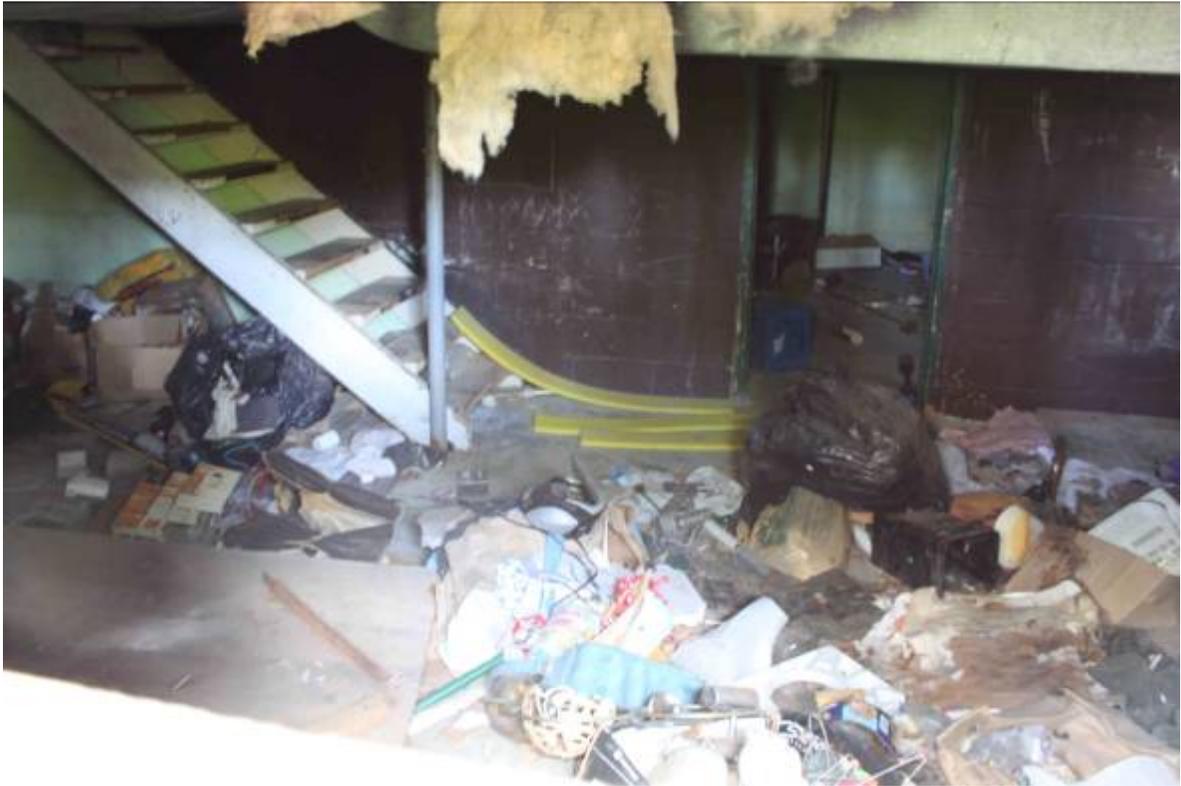
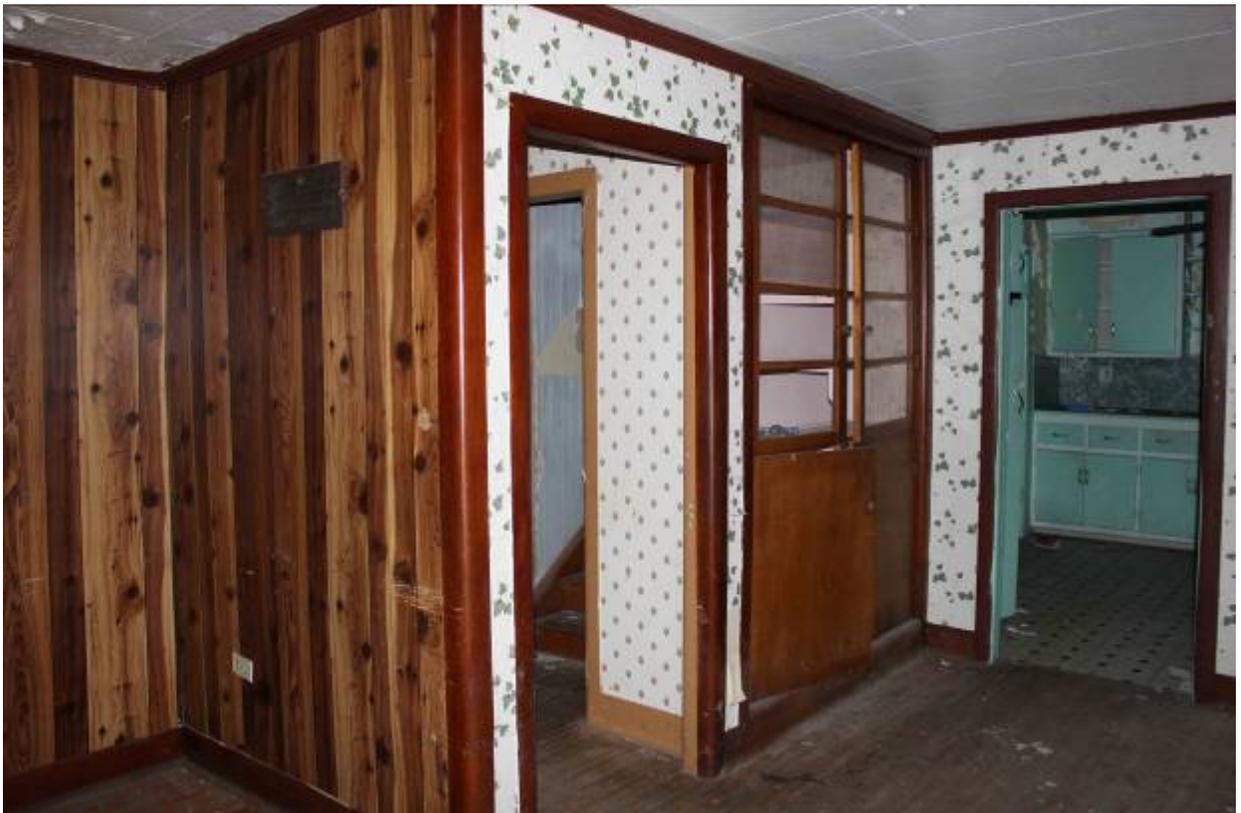
Fig. 2-14 May 10, 2012 Site Visit – 9570 Keele Street. Photo by Cultural Services.

| ALTERATIONS | EVALUATION CRITERIA | GRADING | COMMENTS |
|---|--|---|--|
| | F- Exterior of building has changed somewhat and original character compromised. (40-60% intact) | F- 8 | Checklist includes: Original Exterior Siding 0% Windows/doors: Likely 20%- (75% boarded up) Verandahs/trim 30% Foundation/location 10% Structural Plan (no modern or unsympathetic additions) 10% Total: 85% |

2. That Heritage Vaughan consider the demolition of the structures at the subject property and that if it is approved, that the following conditions be included with the approval:

- a. That the demolition clearance be effective from the date of the Building Permit approval, and;
 - b. That the owner and applicant work together with Cultural Services in the design of a replacement structure and they return for approval of a Heritage Permit for the same at a later Heritage Vaughan Committee meeting, and;
