COMMITTEE OF THE WHOLE – JANUARY 17, 2012

TRAFFIC OPERATIONS REVIEW STEGMAN'S MILL ROAD WARD 1

TECHNICAL ANALYSIS AND REVIEW OF STEGMAN'S MILL ROAD

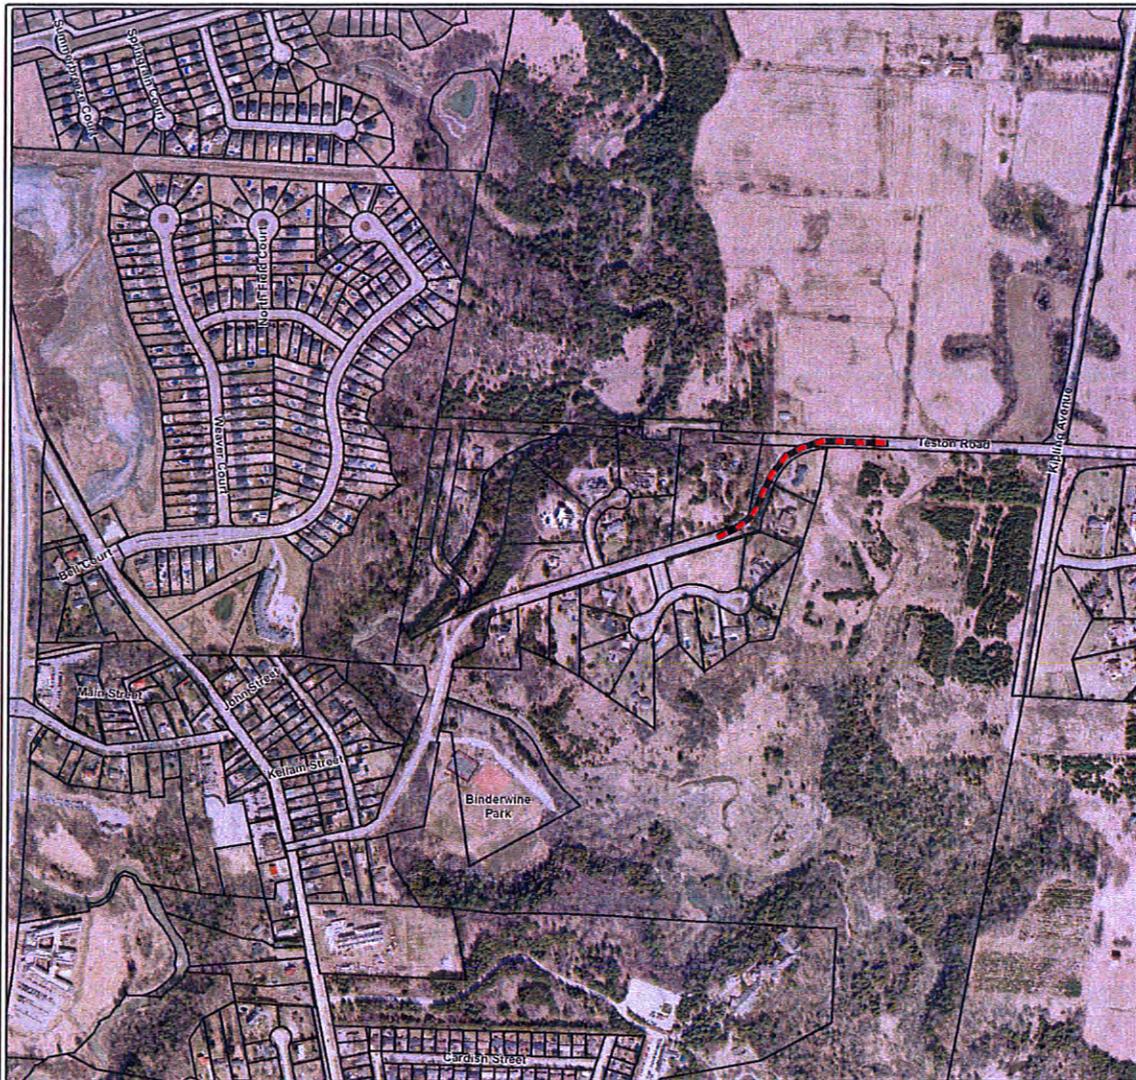
ATTACHMENT No. 3

PROPOSED PAVEMENT MODIFICATIONS STEGMAN'S MILL ROAD

Proposed Rumble Bars/Rumble Strips/Pavement Markings

1. Install a standard street lighting system, at an estimated cost of \$160,000;
2. Pavement modifications including rumble bars and/or rumble strips be installed along the east end of Stegman's Mill Road at an estimated cost of \$40,000.00; and
3. Durable pavement markings are installed for the east end of Stegman's Mill Road at an estimated cost of \$20,000.00.

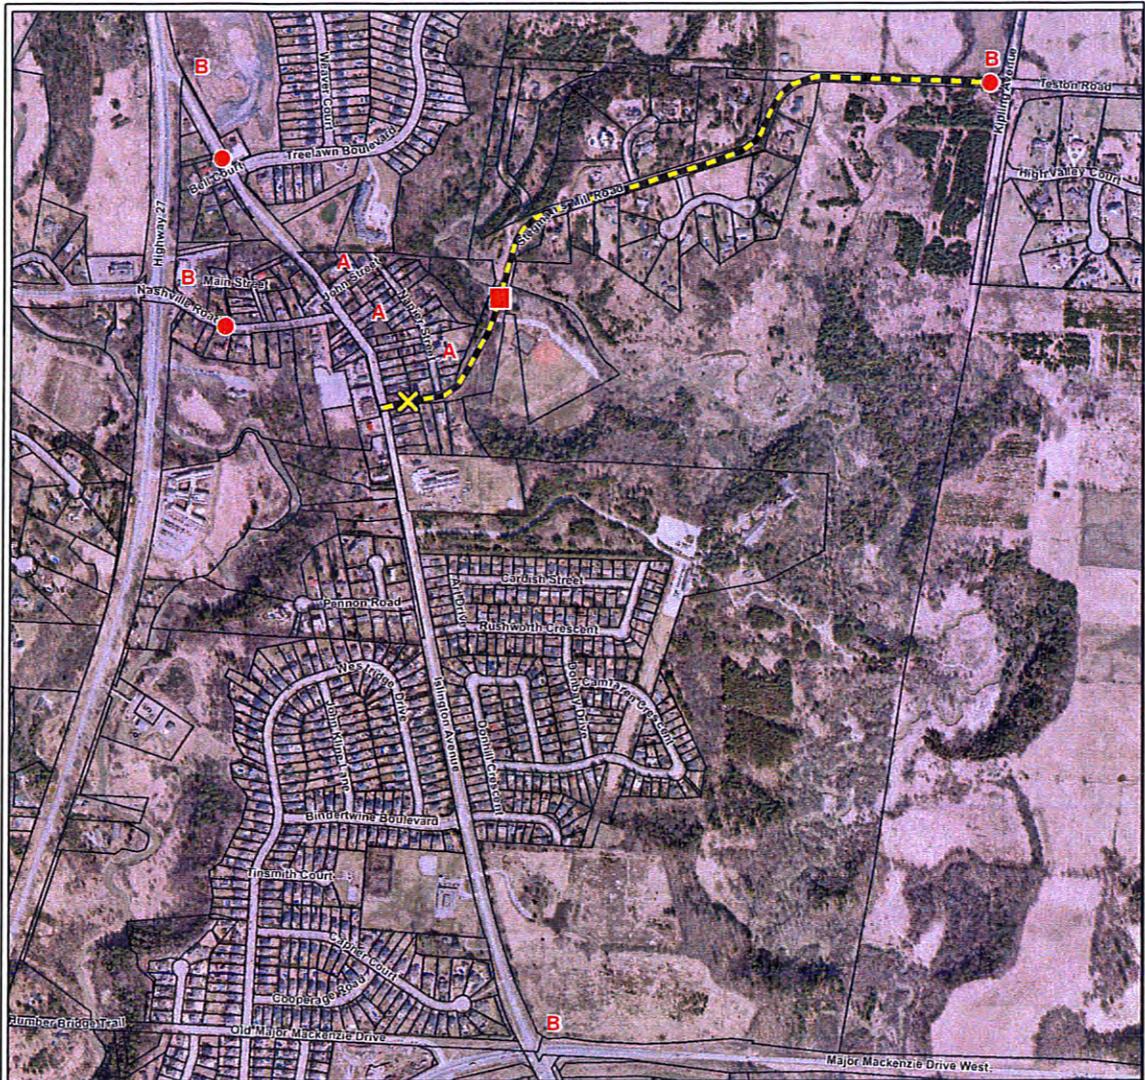
FIGURE No. 1

OPERATIONAL REVIEW REPORT STEGMAN'S MILL ROAD

| Road Under Review | Automated Traffic Recorder Locations |
| Napier Infiltration Study Locations | Radar Message Board Location |
| Islington/Nashville Infiltration Study Locations | Vehicle Classification Study Location |

Heavy Truck percentages range from 5-6% for Stegman's Mill Road. There is an existing 5 tonnes per axle prohibition all-year round on this road. The Classification Percentages and Volumes are representing the total counted from May 2 to May 6, 2011. Refer to Figure No. 1 for the locations of the traffic studies.

Overall Inbound volumes were very low during the AM and PM periods. Staff did not recommend any turning prohibitions as a result of this study. Study locations for the infiltration studies, the Automatic Traffic Recorders, and the Speed Compliance Program are shown in Attachment No. 2.
