## COMMITTEE OF THE WHOLE – APRIL 24, 2012

### REQUEST FOR DEMOLITION OF THE GARAGE/CARRIAGE HOUSE STRUCTURE, 197 WOODBRIDGE AVENUE – WARD 2

**RE: Peer Review of the Report  
“Doctor McLean Carriage House, 197 Woodbridge Ave., Vaughan”  
Prepared by Nino Rico Architect and REMY Consulting Eng.**

Doctor McLean Carriage House  
197 Woodbridge Ave., Vaughan

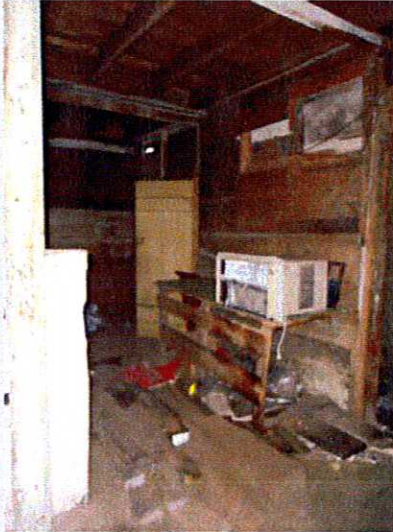
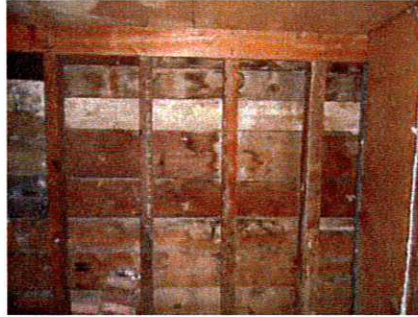
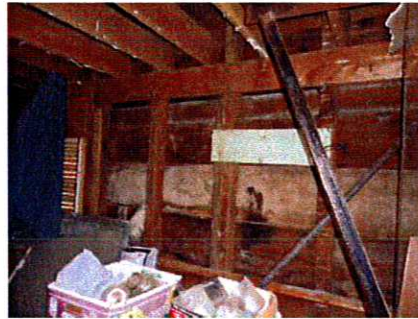
## Rotted Wall Sheathing

Severely Water Stained Sheathing

Note: Dry Rot in Wall Sheathing at second floor level- West Elevation

Note:  
Severe Water Stained Sheathing in direct contact with structural framing
